Tree Assessment Report Lions Pioneer Park Streaky Bay

Prepared for
District Council of Streaky Bay

Prepared by: Sarah Nunn

23 February 2023

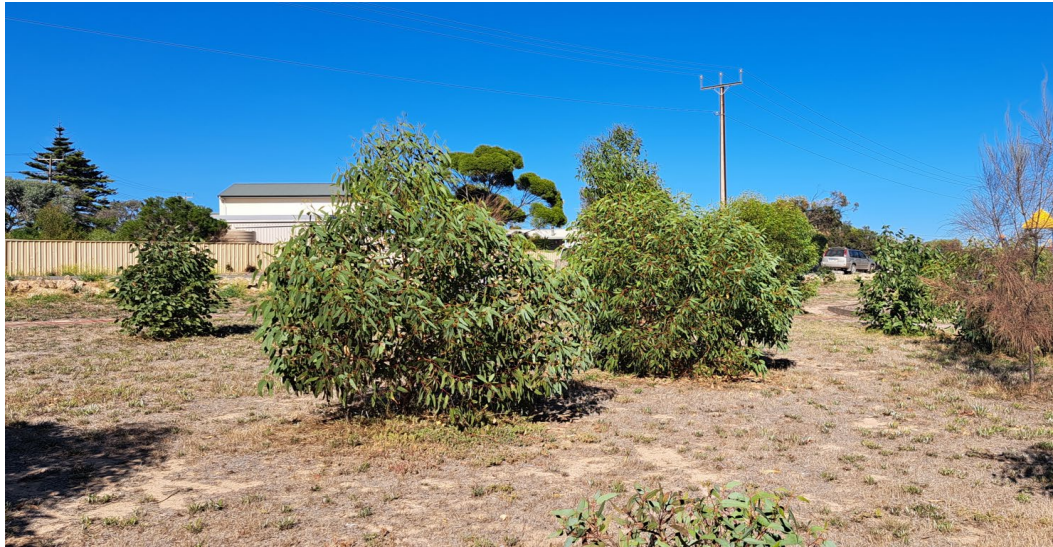
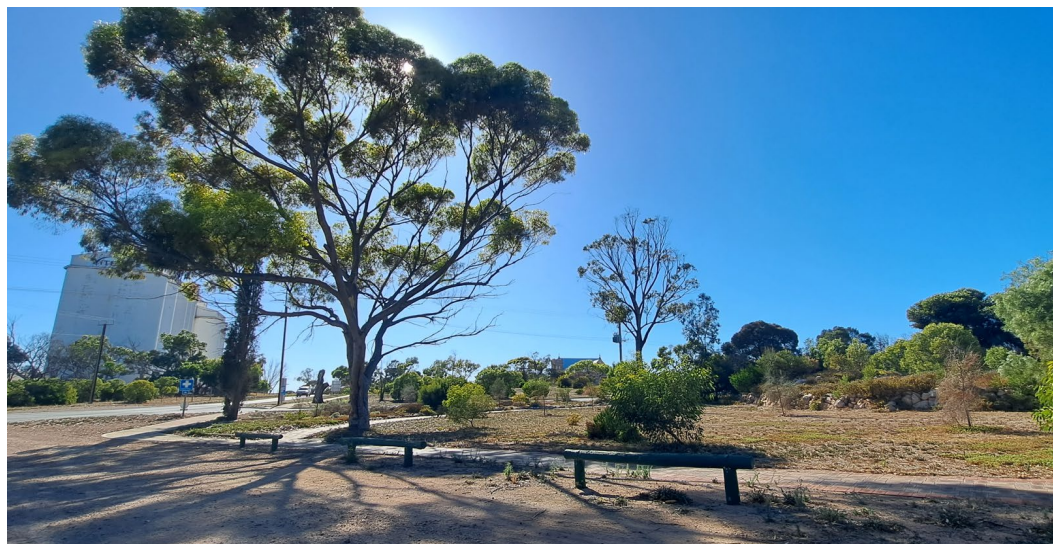
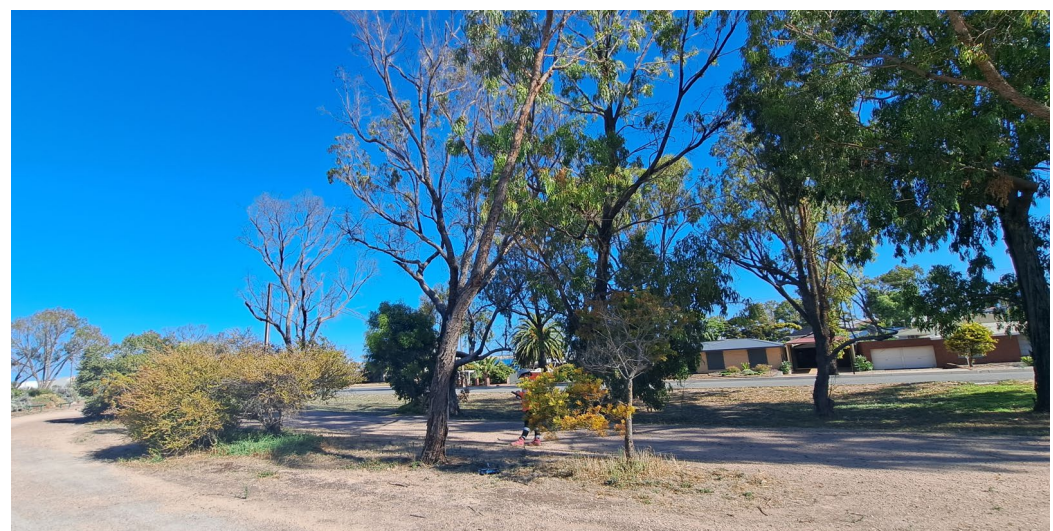
Figure 3 (top) young tree establishment. Figure 4 (centre) grey gum at park entry. Figure 5 (bottom) varying condition of existing tuart trees.

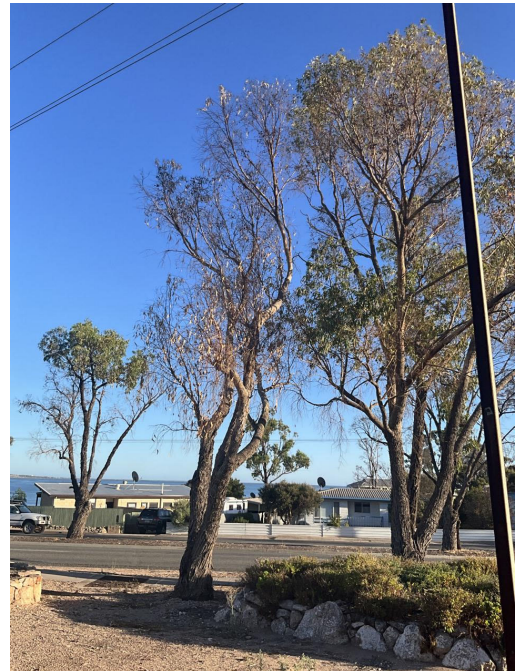
Common name: Tuart

Height (m): 14	Structure: Fair
Width (m): 8	Health: Very poor
DBH (cm): 72 Measured	Maturity: Overmature
Origin: Australian	ULE (years): 1 - 5
Retained?: Retained.	Form:
Ret Value: Very low	Dormancy: Evergreen
Amenity value: Low	Recommendation: Potentially remove.
Works Required:	
Mulch

Occupancy = Property-\$2,200 - \$22,000. Pedestrians >1 per hour - 10 per hour. Road-363 vehicles @ 110kph; 449 vehicles @ 80kph; 649 vehicles @ 50kph: 1/72 (72). Failure Size = 2.5cm - 10cm 1/82 (82). Failure potential = 0.001% - 0.01% 1/10,000 (10000).

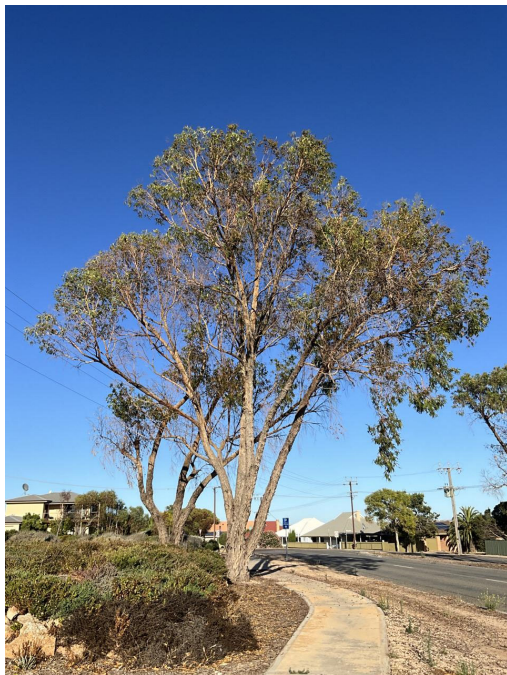
Height (m): 16	Structure: Fair
Width (m): 14	Health: Fair
DBH (cm): 73 Measured	Maturity: Mature
Origin: Australian	ULE (years): 15 - 25
Retained?: Retained.	Form: Good
Ret Value: High	Dormancy: Evergreen
Amenity value: High	Recommendation: Retain.

Occupancy = Property-\$2,200 - \$22,000. Pedestrians ->1 per hour - 10 per hour. Road-363 vehicles @ 110kph; 449 vehicles @ 80kph; 649 vehicles @ 50kph: 1/72 (72). Failure Size = 2.5cm - 10cm 1/82 (82). Failure potential = 0.01% - 0.1% 1/1,000 (1000).

Deadwood > 25mm

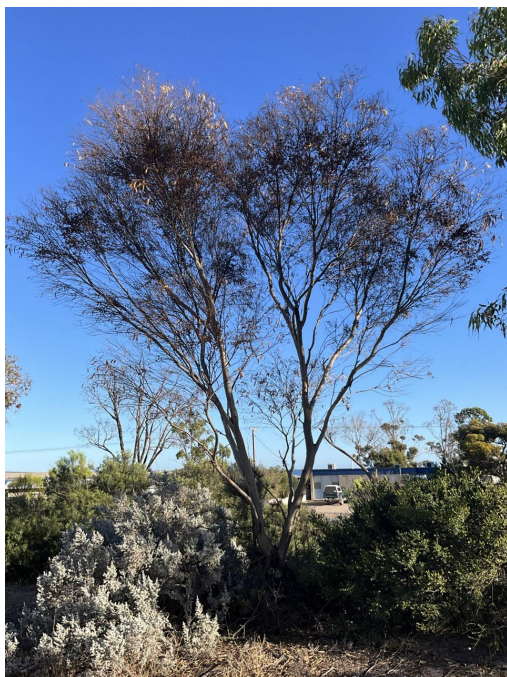
Height (m): 6	Structure: Good
Width (m): 6	Health: Very poor
DBH (cm): 27 Measured	Maturity: Mature
Origin: Australian	ULE (years): 1 - 5
Retained?: Retained.	Form: Good
Ret Value: Very low	Dormancy: Evergreen
Amenity value: Low	Recommendation: Retain.

Occupancy = Property-\$100 - \$2,200. Pedestrians - >1 per day - 1 per hour. Road-36 vehicles @ 110kph; 45 vehicles @ 80kph; 65 vehicles @ 50kph: 1/720 (720). Failure Size = <2.5cm 1/2500 (2500). Failure potential = 0.001% - 0.01% 1/10,000 (10000).

Irrigate

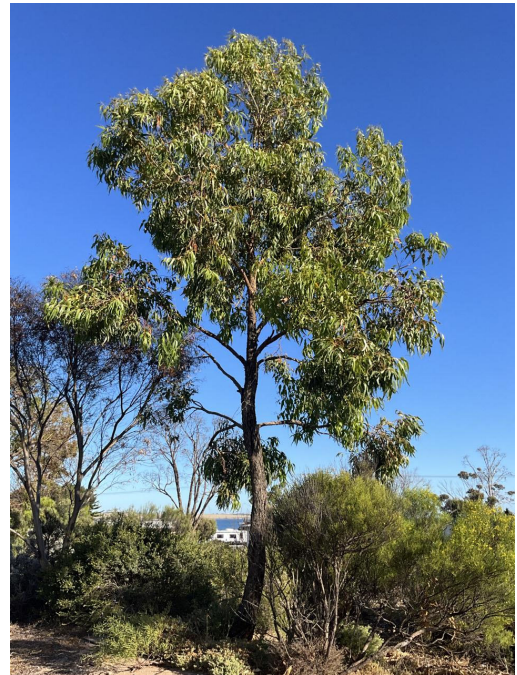
Height (m): 8	Structure: Good
Width (m): 6	Health: Good
DBH (cm): 20 Measured	Maturity: Semi Mature
Origin: Australian	ULE (years): 25 - 50
Retained?: Retained.	Form: Good
Ret Value: Moderate	Dormancy: Evergreen
Amenity value: Moderate	Recommendation: Retain.

Occupancy = Property-\$100 - \$2,200. Pedestrians - >1 per day - 1 per hour. Road-36 vehicles @ 110kph; 45 vehicles @ 80kph; 65 vehicles @ 50kph: 1/720 (720). Failure Size = <2.5cm 1/2500 (2500). Failure potential = 0.001% - 0.01% 1/10,000 (10000).

No action required

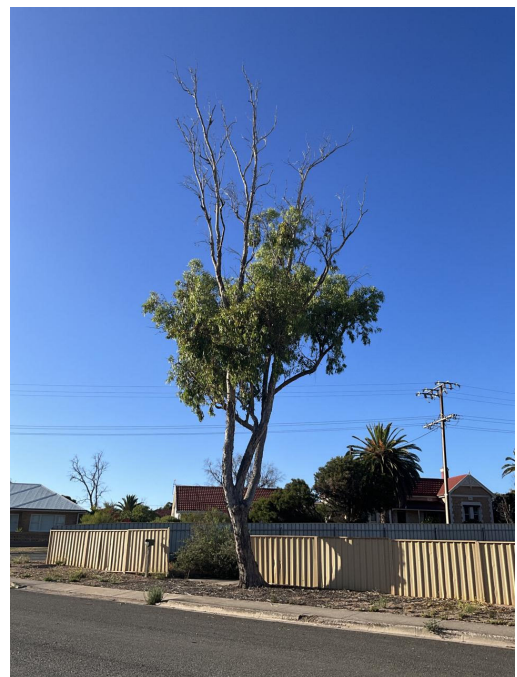
Height (m): 15	Structure: Poor
Width (m): 7	Health: Poor
DBH (cm): 49 Measured	Maturity: Overmature
Origin: Australian	ULE (years): 1 - 5
Retained?: Retained.	Form: Fair
Ret Value: Low	Dormancy: Evergreen
Amenity value: Moderate	Recommendation: Potentially remove.

Occupancy = Property-\$2,200 - \$22,000. Pedestrians >1 per hour - 10 per hour. Road-363 vehicles @ 110kph; 449 vehicles @ 80kph; 649 vehicles @ 50kph: 1/72 (72). Failure Size = 2.5cm - 10cm 1/82 (82). Failure potential = 0.01% - 0.1% 1/1,000 (1000).

Deadwood > 25mm

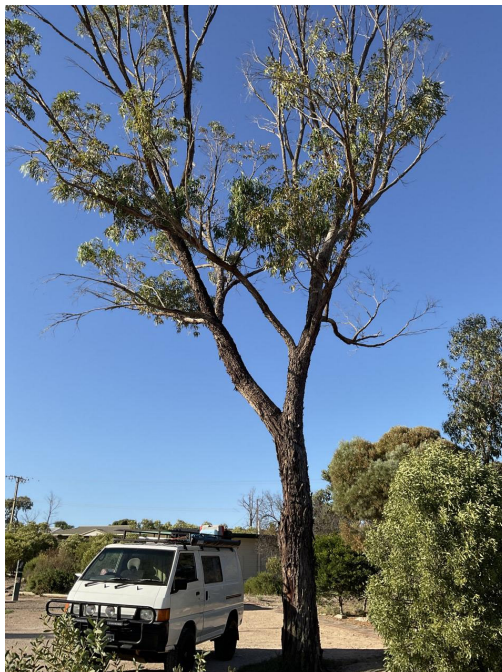
Height (m): 13	Structure: Fair
Width (m): 15	Health: Poor
DBH (cm): 56 Measured	Maturity: Overmature
Origin: Australian	ULE (years): 5 - 15
Retained?: Retained.	Form: Fair
Ret Value: Low	Dormancy: Evergreen
Amenity value: Moderate	Recommendation: Retain.

Occupancy = Property-\$2,200 - \$22,000. Pedestrians >1 per hour - 10 per hour. Road-363 vehicles @ 110kph; 449 vehicles @ 80kph; 649 vehicles @ 50kph: 1/72 (72). Failure Size = 2.5cm - 10cm 1/82 (82). Failure potential = 0.01% - 0.1% 1/1,000 (1000).

Deadwood > 25mm

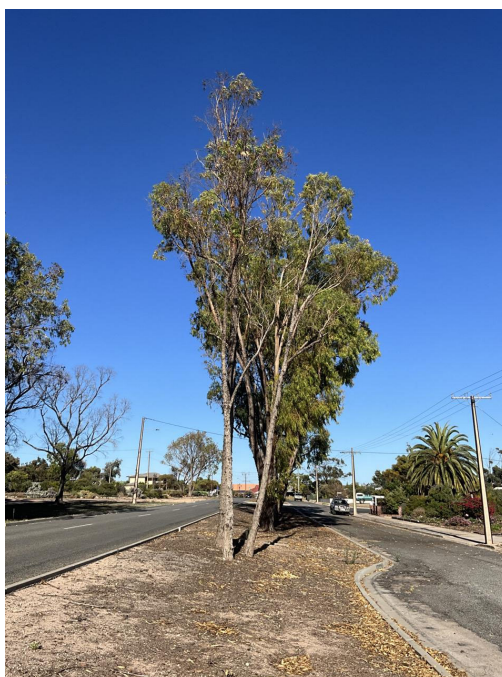
Height (m): 12	Structure: Fair
Width (m): 4	Health: Poor
DBH (cm): 20 Measured	Maturity: Overmature
Origin: Australian	ULE (years): 1 - 5
Retained?: Retained.	Form: Fair
Ret Value: Very low	Dormancy: Evergreen
Amenity value: Low	Recommendation: Potentially remove.

Occupancy = Property-\$2,200 - \$22,000. Pedestrians >1 per hour - 10 per hour. Road-363 vehicles @ 110kph; 449 vehicles @ 80kph; 649 vehicles @ 50kph: 1/72 (72). Failure Size = 2.5cm - 10cm 1/82 (82). Failure potential = 0.01% - 0.1% 1/1,000 (1000).

Deadwood > 25mm

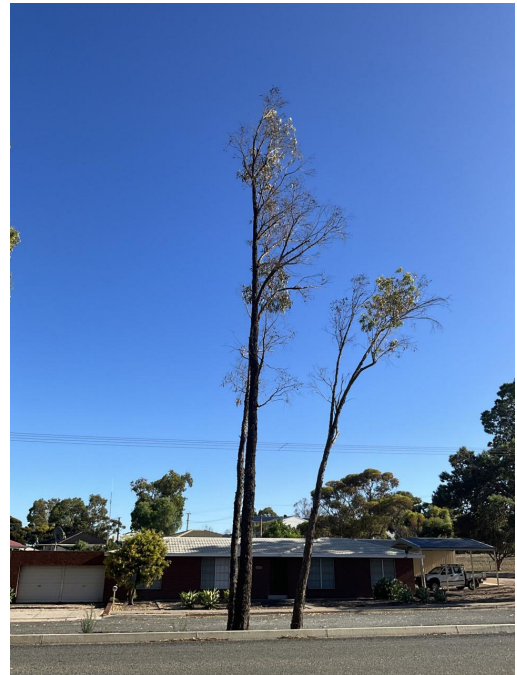
Common name: Tuart

Height (m): 16	Structure: Fair
Width (m): 5	Health: Very poor
DBH (cm): 32 Measured	Maturity: Overmature
Origin: Australian	ULE (years): 1 - 5
Retained?: Retained.	Form: Fair
Ret Value: Very low	Dormancy: Evergreen
Amenity value: Low	Recommendation: Potentially remove.
Works Required:	
Deadwood > 25mm

Occupancy = Property-\$100 - \$2,200. Pedestrians - >1 per day - 1 per hour. Road-36 vehicles @ 110kph; 45 vehicles @ 80kph; 65 vehicles @ 50kph: 1/720 (720). Failure Size = 2.5cm - 10cm 1/82 (82). Failure potential = 0.01% - 0.1% 1/1,000 (1000).

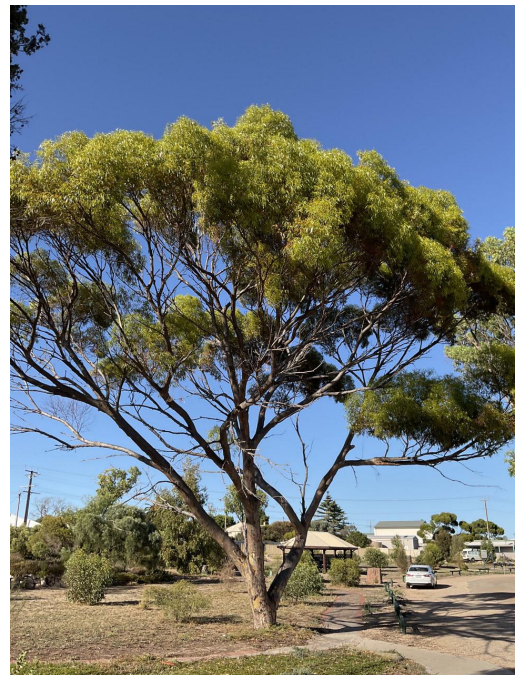
Common name: Grey Gum

Height (m): 13	Structure: Good
Width (m): 18	Health: Good
DBH (cm): 57 Measured	Maturity: Mature
Origin: Australian	ULE (years): 25 - 50
Retained?: Retained.	Form: Good
Ret Value: High	Dormancy: Evergreen
Amenity value: High	Recommendation: Retain.
Works Required:	
Deadwood > 25mm

Occupancy = Property-\$100 - \$2,200. Pedestrians - >1 per day - 1 per hour. Road-36 vehicles @ 110kph; 45 vehicles @ 80kph; 65 vehicles @ 50kph: 1/720 (720). Failure Size = <2.5cm 1/2500 (2500). Failure potential = 0.0001% - 0.001% 1/100,000 (100000).

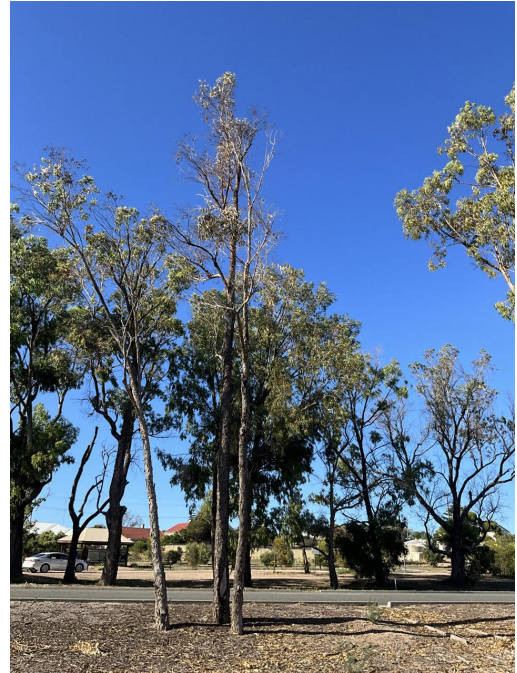
Height (m): 13	Structure: Fair
Width (m): 4	Health: Very poor
DBH (cm): 20 Measured	Maturity: Overmature
Origin: Australian	ULE (years): 1 - 5
Retained?: Retained.	Form: Fair
Ret Value: Very low	Dormancy: Evergreen
Amenity value: Low	Recommendation: Potentially remove.

Occupancy = Property-\$2,200 - \$22,000. Pedestrians >1 per hour - 10 per hour. Road-363 vehicles @ 110kph; 449 vehicles @ 80kph; 649 vehicles @ 50kph: 1/72 (72). Failure Size = 2.5cm - 10cm 1/82 (82). Failure potential = 0.01% - 0.1% 1/1,000 (1000).

Irrigate

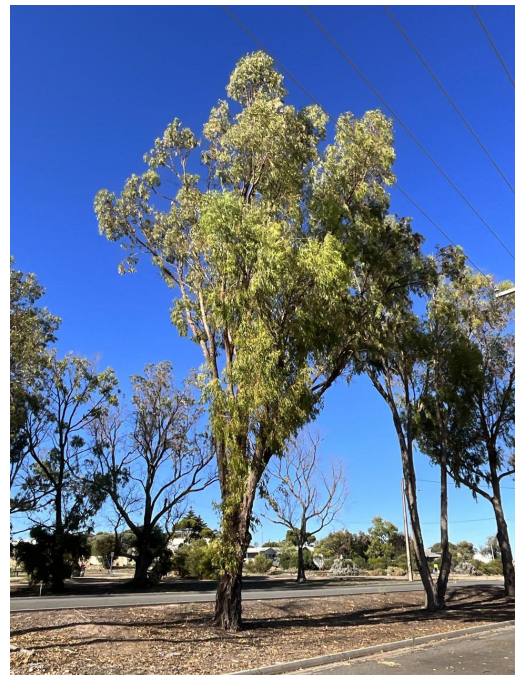
Height (m): 17	Structure: Fair
Width (m): 15	Health: Fair
DBH (cm): 78 Measured	Maturity: Mature
Origin: Australian	ULE (years): 25 - 50
Retained?: Retained.	Form: Fair
Ret Value: High	Dormancy: Evergreen
Amenity value: High	Recommendation: Retain.

Occupancy = Property-\$2,200 - \$22,000. Pedestrians >1 per hour - 10 per hour. Road-363 vehicles @ 110kph; 449 vehicles @ 80kph; 649 vehicles @ 50kph: 1/72 (72). Failure Size = 2.5cm - 10cm 1/82 (82). Failure potential = 0.001% - 0.01% 1/10,000 (10000).

Deadwood > 25mm

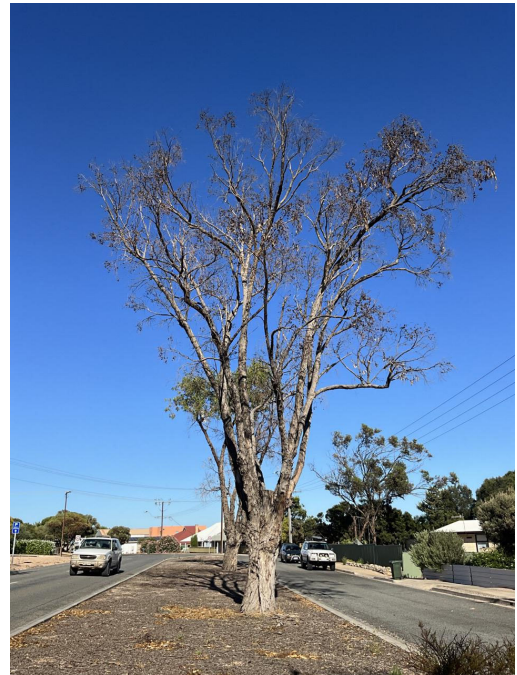
Common name: Tuart

Height (m): 13	Structure: Poor
Width (m): 13	Health: Very poor
DBH (cm): 73 Measured	Maturity: Overmature
Origin: Australian	ULE (years): 1 - 5
Retained?: Retained.	Form: Poor
Ret Value: Very low	Dormancy: Evergreen
Amenity value: Low	Recommendation: Potentially remove.
Works Required:	
Tree remove

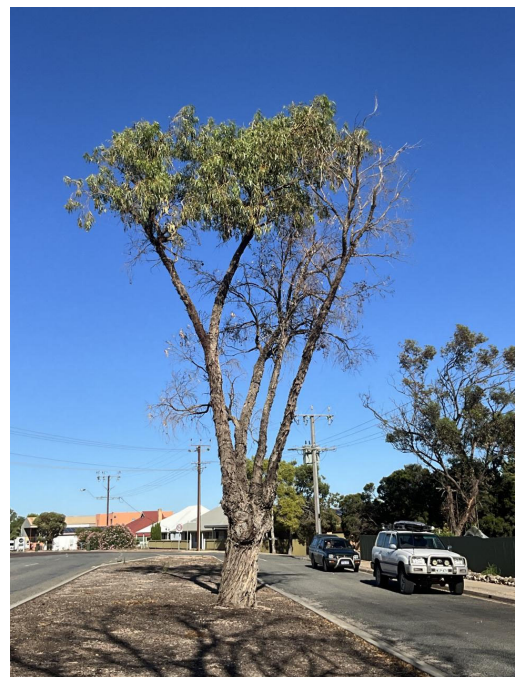
Common name: Tuart

Height (m): 12	Structure: Poor
Width (m): 11	Health: Poor
DBH (cm): 78 Measured	Maturity: Mature
Origin: Australian	ULE (years): 5 - 15
Retained?: Retained.	Form: Fair
Ret Value: Low	Dormancy: Evergreen
Amenity value: Moderate	Recommendation: Potentially remove.
Works Required:	
Structural prune

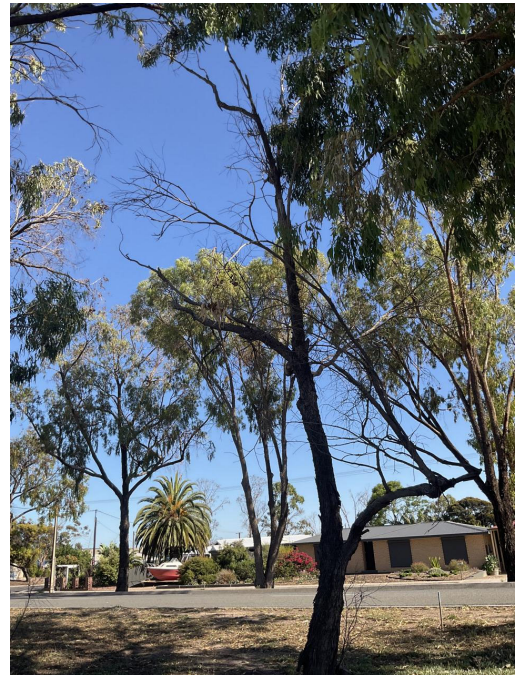
Common name: Tuart

Height (m): 8	Structure: Poor
Width (m): 6	Health: Dead
DBH (cm): 18 Measured	Maturity: Semi Mature
Origin: Australian	ULE (years): 0
Retained?: Retained.	Form: Fair
Ret Value: Very low	Dormancy: Evergreen
Amenity value: Low	Recommendation: Remove.
Works Required:	
Deadwood > 25mm

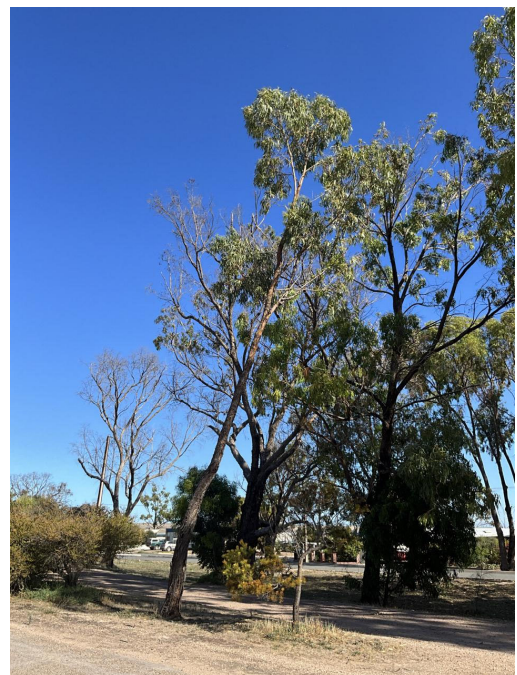
Common name: Tuart

Height (m): 14	Structure: Fair
Width (m): 6	Health: Good
DBH (cm): 27 Measured	Maturity: Semi Mature
Origin: Australian	ULE (years): 25 - 50
Retained?: Retained.	Form: Fair
Ret Value: Moderate	Dormancy: Evergreen
Amenity value: Moderate	Recommendation: Retain.
Works Required:	
Mulch
