Tree Assessment & Tree Risk Assessment Report

Wells Street Streaky Bay

The District Council of Streaky Bay

12 April 2023

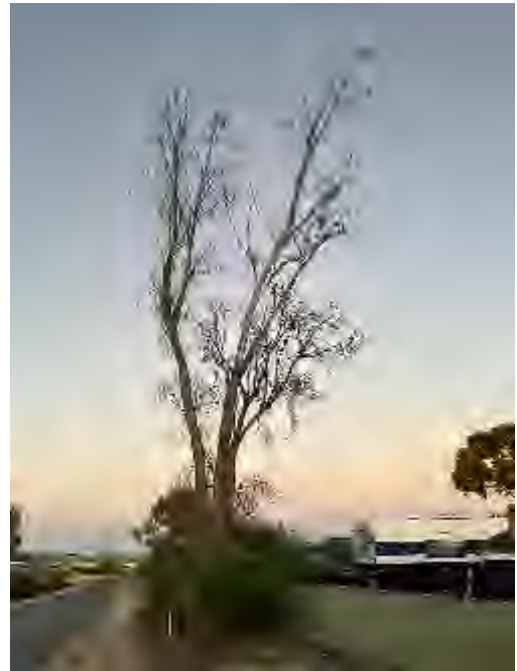
Tree ID: 130

Height (m): 21	Structure: Poor
Width (m): 11	Health: Very poor
DBH (cm): 55 Measured	Maturity: Overmature
Origin: Australian	ULE (years): 1 - 5
Amenity value: Moderate	Form: Poor
Works Required: Irrigate	Dormancy: Evergreen
Priority: High	Recommendation: Retain.

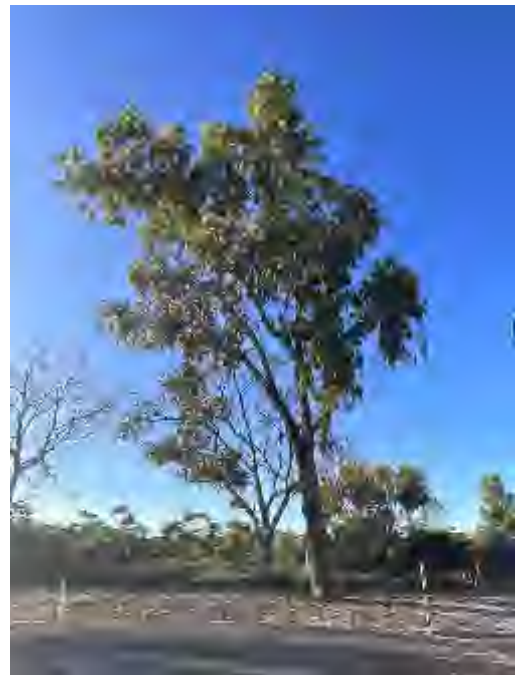
Height (m): 18	Structure: Good
Width (m): 16	Health: Good
DBH (cm): 64 Measured	Maturity: Mature
Origin: Australian	ULE (years): 25 - 50
Amenity value: High	Form:
Works Required:	Dormancy: Evergreen
Weight reduce	Recommendation: Retain.

Works Required:

Weight reduce
