Stormwater Management Plan

Streaky Bay Stormwater Management Plan Review

District Council of Streaky Bay

19 February 2024

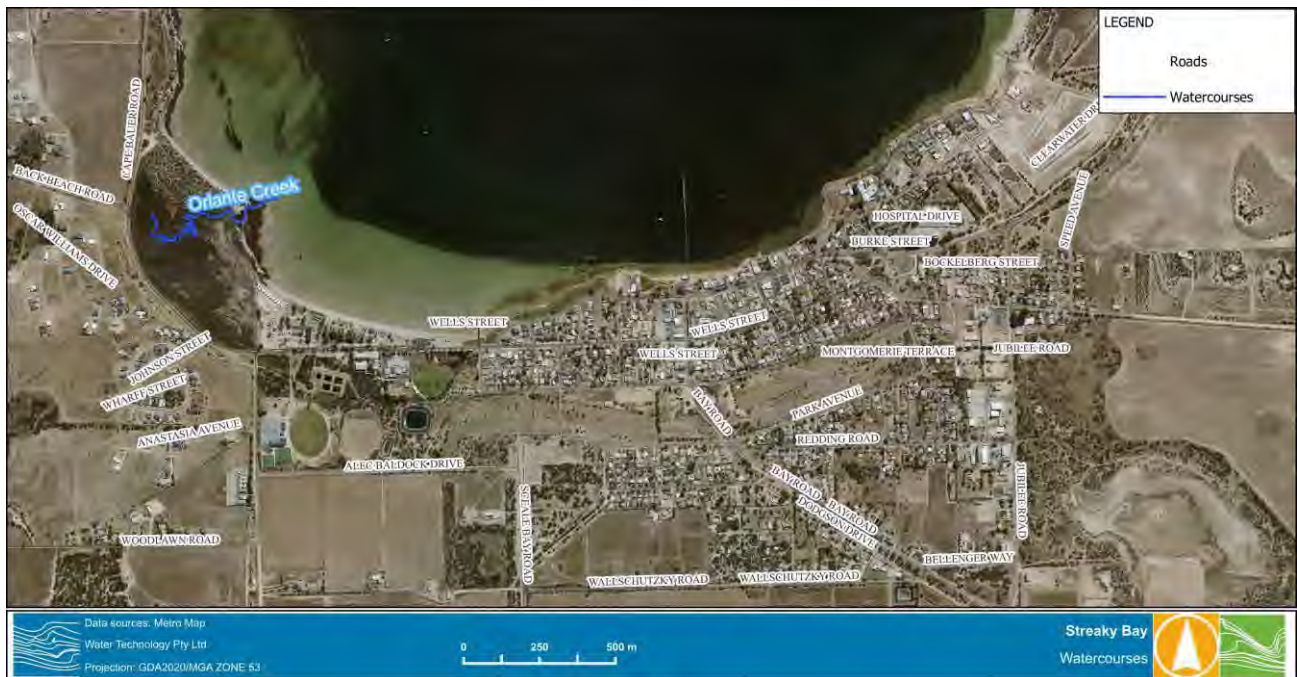
Figure 4-3 Watercourse Location in Streaky Bay

Council has recently had all drainage assets within Streaky Bay digitised, with the existing assets shown in Figure 4-4. Due to the topography of the region, flooding related issues are generally due to rainfall events of a short duration (less than 1 day). As Streaky Bay does not have any significant creeks or rivers, the majority of local flooding is associated with stormwater flows. A single watercourse, Orlande Creek, is present in Streaky Bay within the Samphire wetland as shown in Figure 4-3.

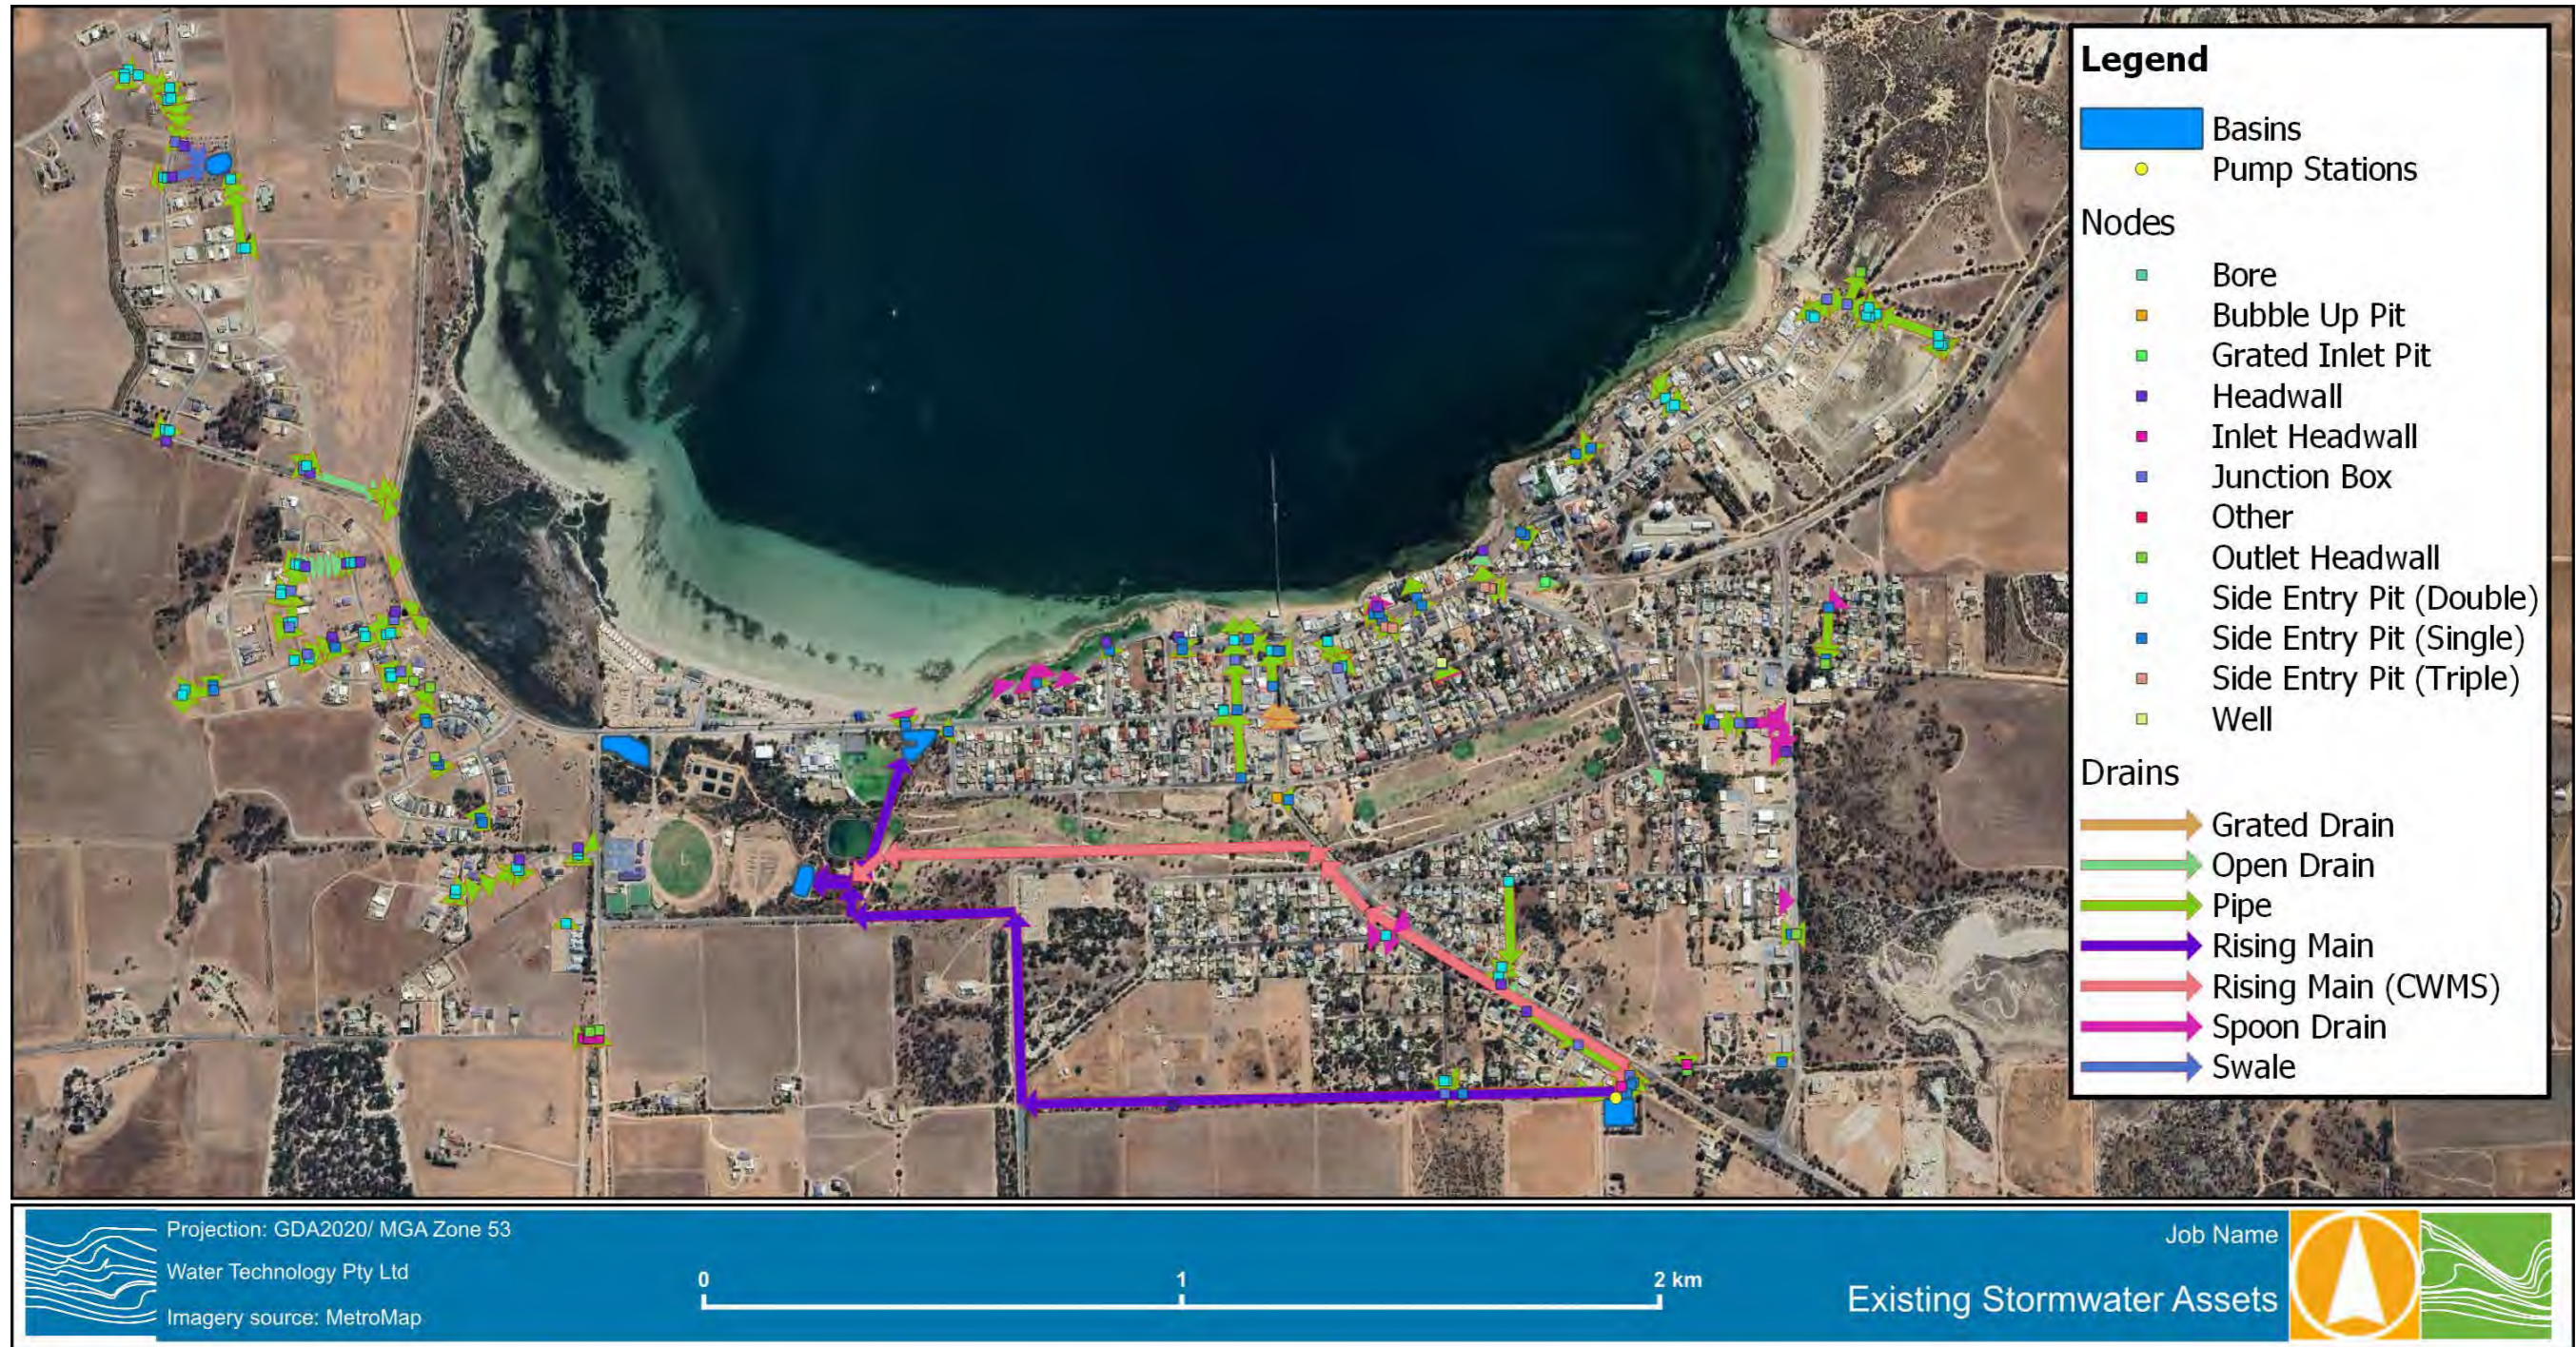
Figure 4-4 Streaky Bay - Existing Stormwater Assets

The flood modelling undertaken for Streaky Bay also included assessment of the pipe network capacity. The pipe capacity % full in both the 1% AEP and 20% AEP events is shown in Figure 4-5 and Figure 4-6. This shows how much of the network is fully utilised in a flood event and provides guidance to the mitigation options. The capacity % can be used to inform the cost/benefit analysis in upgrades to pipe as protection against the 1% AEP event in many cases is unfeasible for pipe networks alone. From the results we can see that some pipes are running full in the 20% AEP event, meaning further investigation may be warranted at these locations.

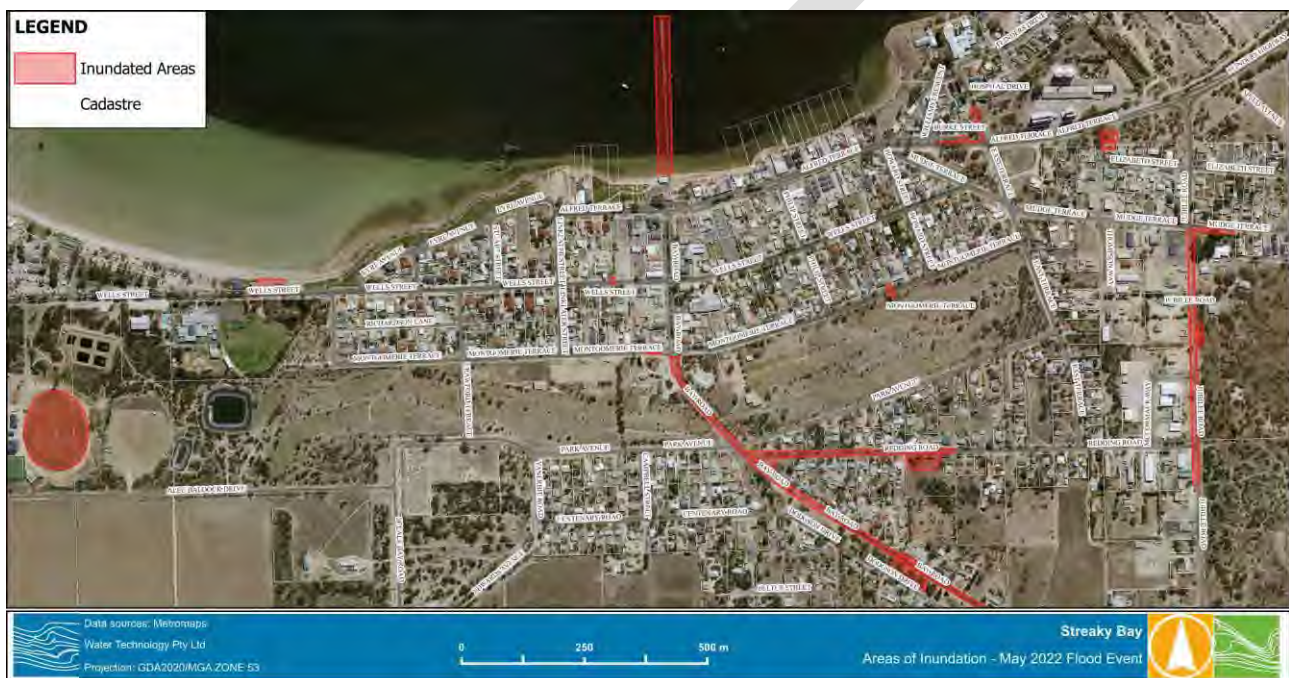
Figure 4-7 Inundated Areas Overview – May 2022 Flood Event

It should be noted that January 2022 received a higher rainfall total of 135.4 mm, however photographs were not available for analysis of this event. Figure 4-7 shows the key areas which were inundated during the May 2022 flood event.

Several sections of Bay Road, Jubilee Road and Wells Street were subjected to inundation, along with localised pooling of water observed on Alfred Terrace, Montgomerie Terrace and Hospital Drive.

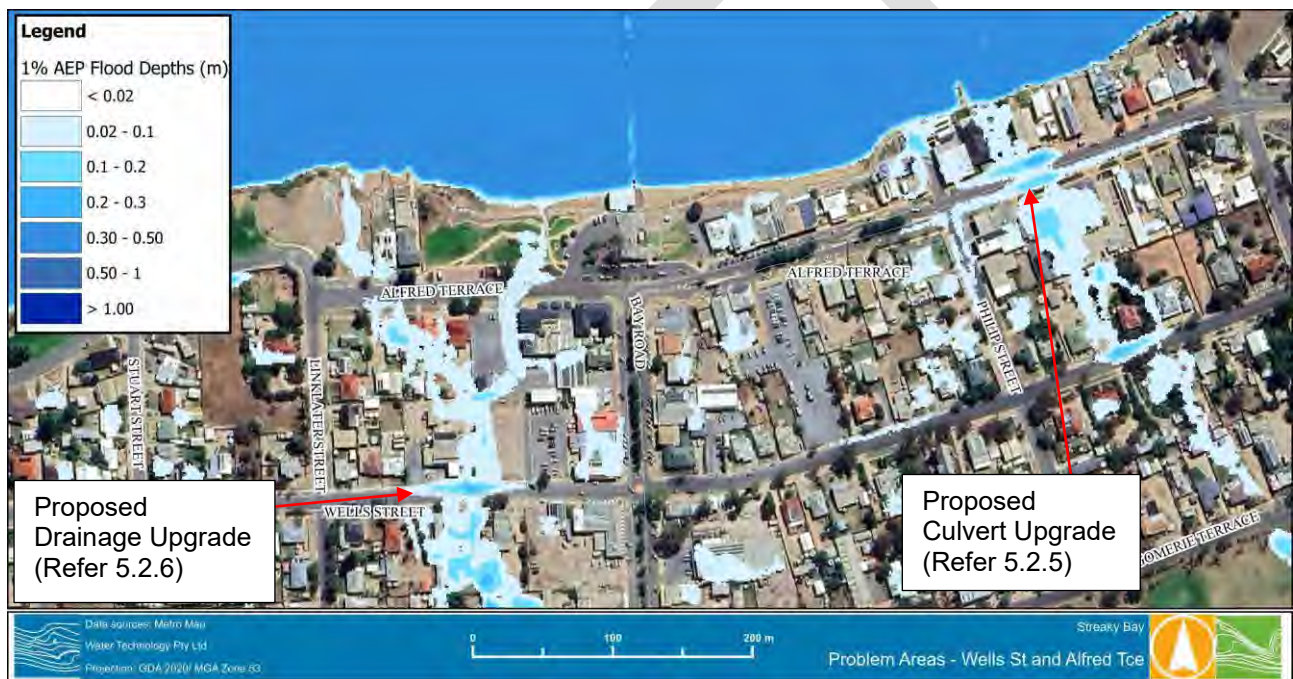
Figure 5-3 Areas along Wells Street and Alfred Terrace subject to inundation

Similar to what is observed on Alfred Terrace, a low point on Wells Street also results in flood impacts where localised pooling is observed. It is proposed that pits and pipes are upgraded along this section with additional grated pits provided to convey the upstream flow into the bay.

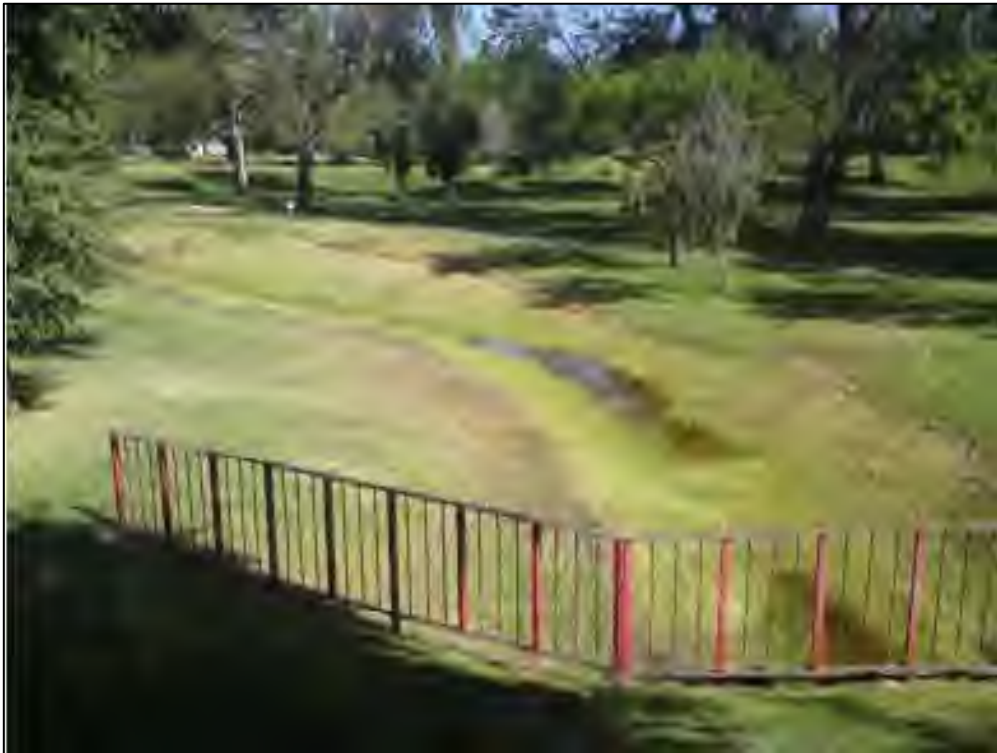
Figure 5-4 Grass swale in Rymill Park – (Source: Chapter 11 - Swale and Buffer Strips, Water Sensitive Urban Design Technical Manual Greater Adelaide Region)

Vegetated swales may be considered as an alternative to concrete drains proposed at different locations in the town. Swales replace the impervious concrete lining with vegetated cross sections and provide a level of water quality treatment in addition to conveyance of stormwater. For instance, the drains proposed along Back Beach Road can be replaced by vegetated swales to achieve a higher level of stormwater treatment before discharging into the bay. A typical grassed swale channel is shown in Figure 5-4.

The selection of vegetated swales as replacements for concrete drains will need to be adopted on a case-by-case basis, depending on Council's budget. The maintenance costs for swales are comparably higher than concrete drains and would also depend on the vegetation available.

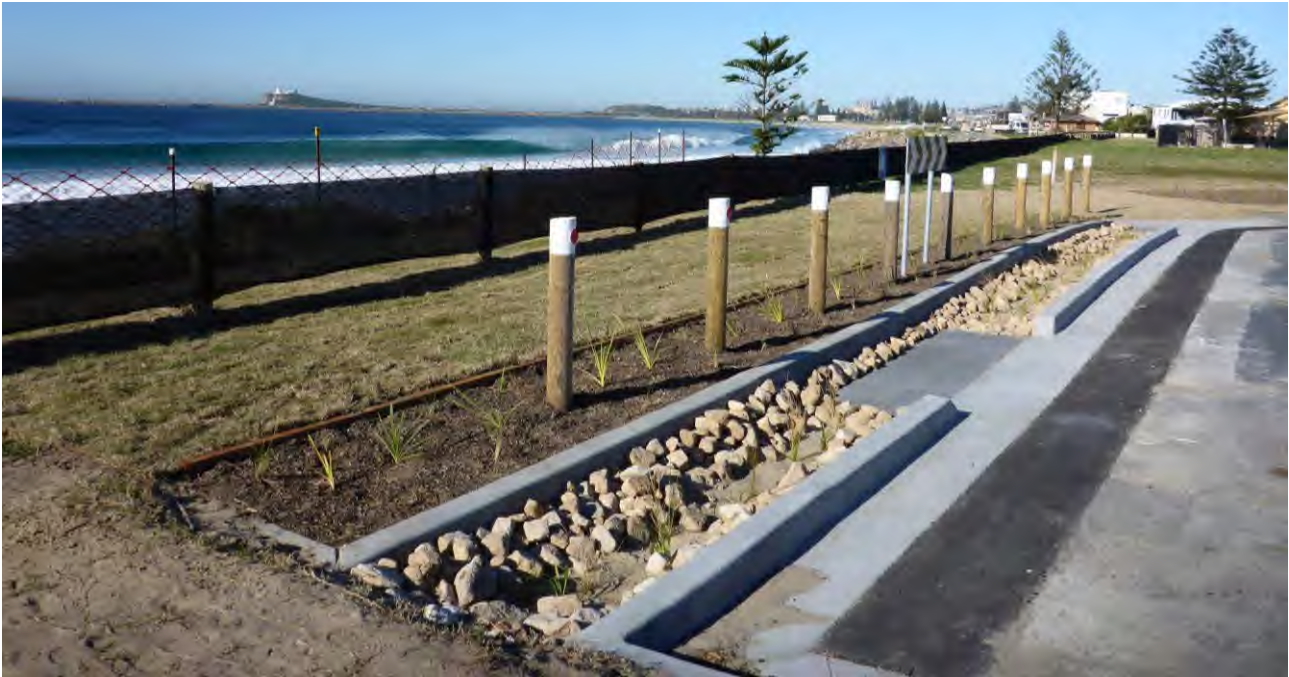
Figure 5-5 Installation of a constructed back-beach aquifer recharge trench at Stockton Beach, NSW (source: NSW State Government).

In their most basic form, dune aquifer recharge systems can be simply constructed. Rather than directing road and car park drainage into stormwater systems, the overland flow can simply be directed to flow across the hind dune or foreshore park area into shore-parallel back beach swales that have been sized to cope with the design runoff volumes (this has previously been discussed in Section 5.3.2, and has a similarly beneficial application in a foreshore setting). These back-beach swales “flood” during heavy rainfall when the parkland is not being used but quickly drain to the aquifer soon after the rainfall event.

Similarly, for situations where the potential flow rate (even during severe events) is likely to be modest, there may be the opportunity to construct a drop structure at the back of the beach which has a permeable base or infiltration trench so that flows can be dissipated into the water table underlying the beach. Common applications of this approach include installation of an upright chamber with a grated opening at the top to allow for surcharge and an infiltration trench or rubble rock base to allow dissipation of water into the beach/dune groundwater. An example of this type of stormwater management option at Stockton Beach in NSW is provided in Figure 5-5, which was designed to both reduce the impact overland flows exacerbating beach erosion and improve groundwater recharge of the local dune system. Where such a structure is employed, it is important to provide a surcharge facility so that flows beyond the structures dissipating capability can be catered for.

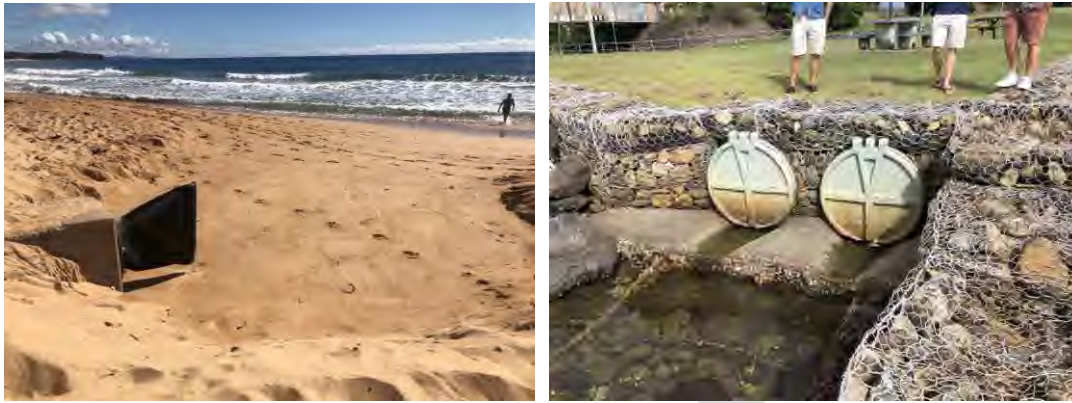
Figure 5-6 Left: Example of a duckbill outlet treatment at Collaroy Beach, NSW. Right: Example of one-way tidal flaps at an estuarine stormwater outlet in Coffs Harbour, NSW

A key issue for the stormwater network over the coming decades will be to manage the impacts of sea level rise on its core drainage function. As sea levels rise, the potential for saline backflows propagating through the network and inundating low lying land will increase in both magnitude and frequency. Future adaptation measures may include relocating or raising the invert level of coastal outlets. However, in the short term, common adaptation measures include the installation of one-way valves at outlets, such as tidal flaps and rubber “duck bills” (see Figure 5-6).

End treatments such as tidal flaps and duckbills can also mitigate the impacts of coastal hazards on foreshore outlets. Stormwater outlets at beaches (such as that on Wells Street) and open coast headland settings are commonly exposed to periodic wave attack, which can result in a water hammer like effect on the flow in pipes and culverts as the wave impacts on the exposed ocean end. This can lead to joints being blown apart and/or “blow holes” developing at weak points in the pipe/culvert.

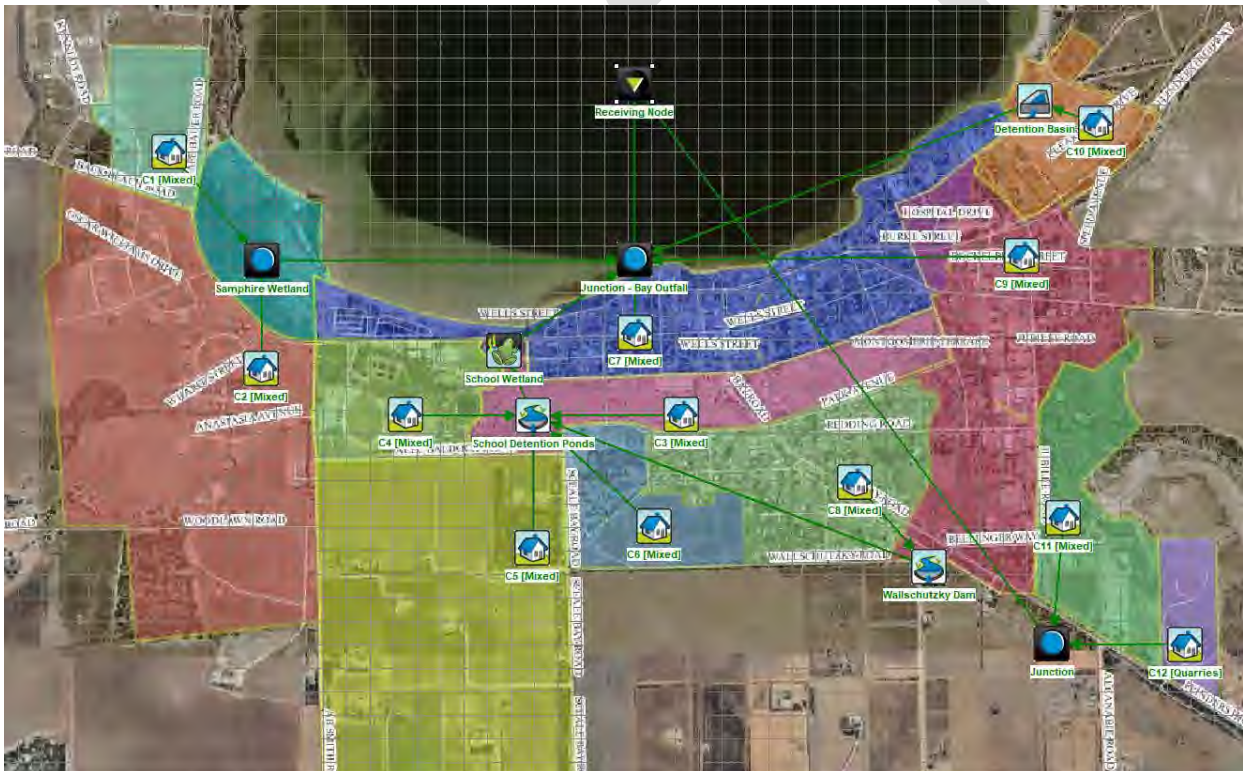
Figure A-12 MUSIC Model Setup – Existing Conditions

Figure A-12 shows the final MUSIC Model setup. The below sub-sections A-3-4 to A-3-3 discuss each modelling component in detail.

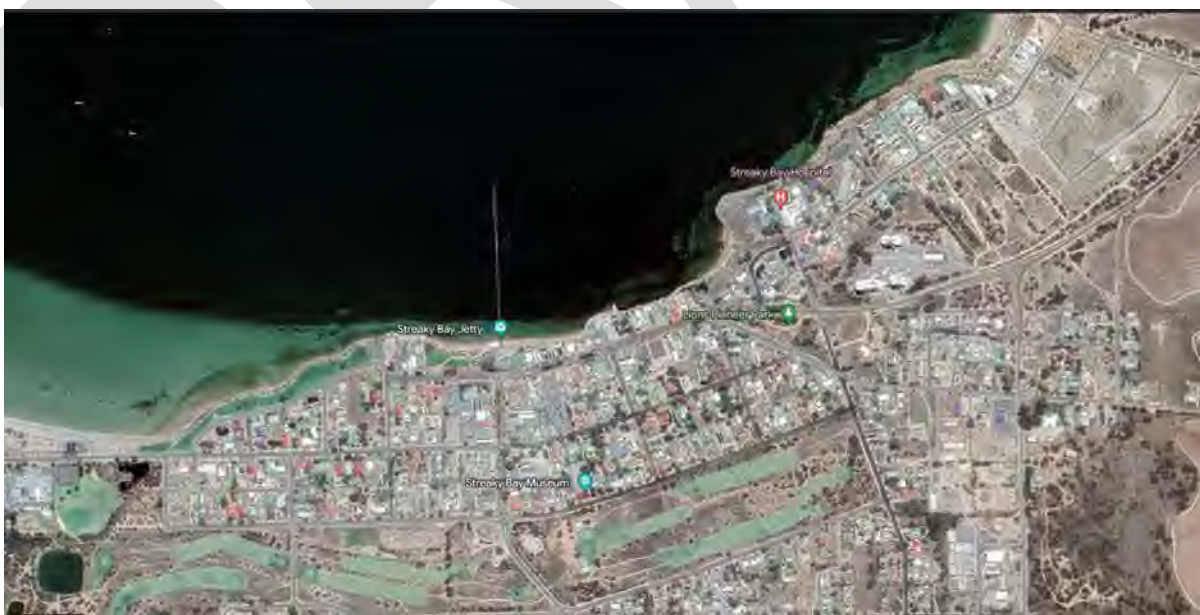
Figure 2-2 Focus area in Streaky Bay with known stormwater issues

- The low-lying residential and industrial areas along Mudge Terrace and Jubilee Road.
- The 'Killas' property on Wells Street, which is situated in a depression.
- Alfred Terrace and Bockleberg Street properties which receive runoff from the Viterra Silos to the north.
- Properties within the block bordered by Williams Court and Hospital Drive, which intercept the stormwater flow path.
- Doctors Beach, which receives outflow from the Streaky Bay Area School detention pond / wetland system.
- Bay Road / Dodgson Drive, this area acts as a catchment area for the surrounding streets and filters to a single point that allows entry into the Wallschutzky Stormwater Catchment Pond

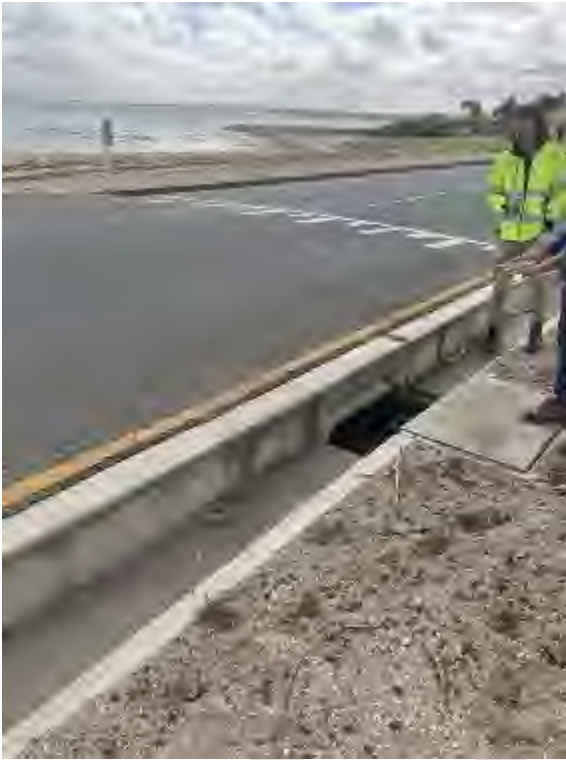
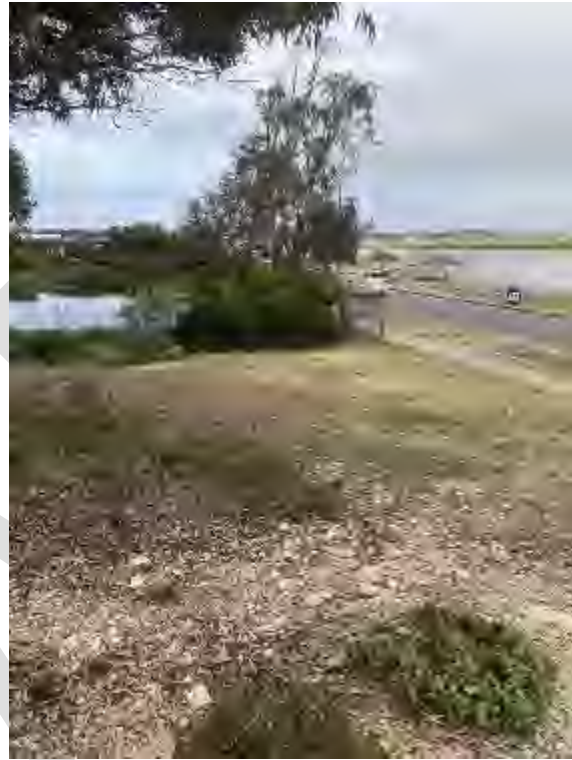
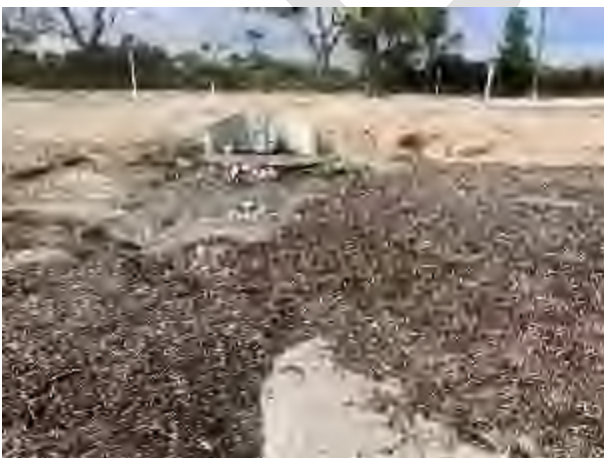
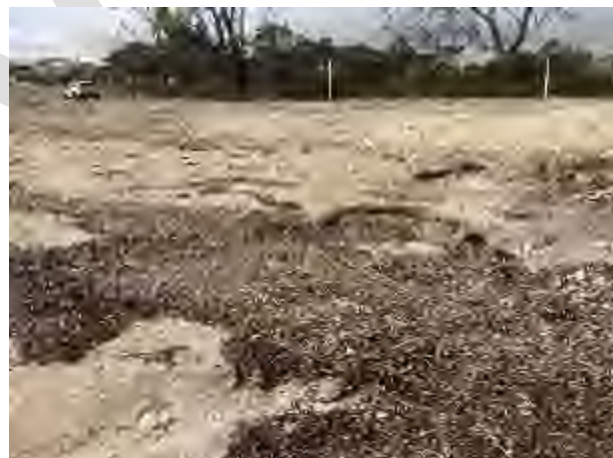
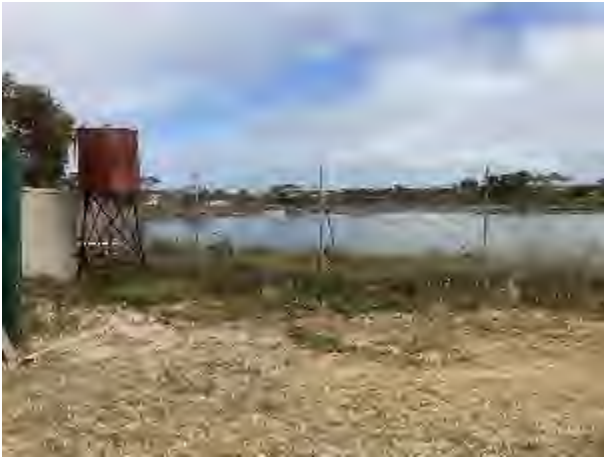
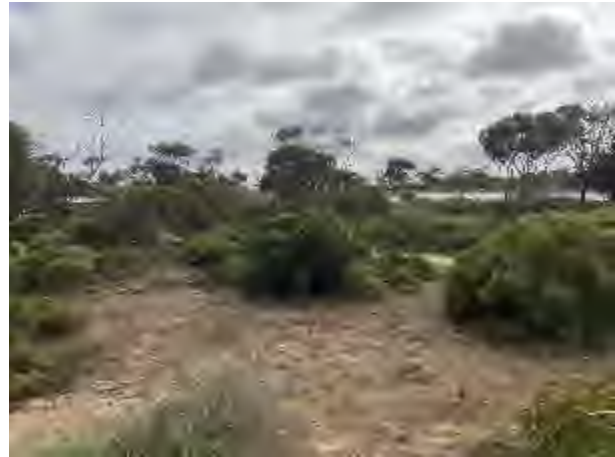
B-1 Wetland / Wells Street

Wetland volume compromised with installation of new speed hump. Stormwater pipe now allowing water to freely flow out to bay instead of retaining water. Consider possible remediation measures.

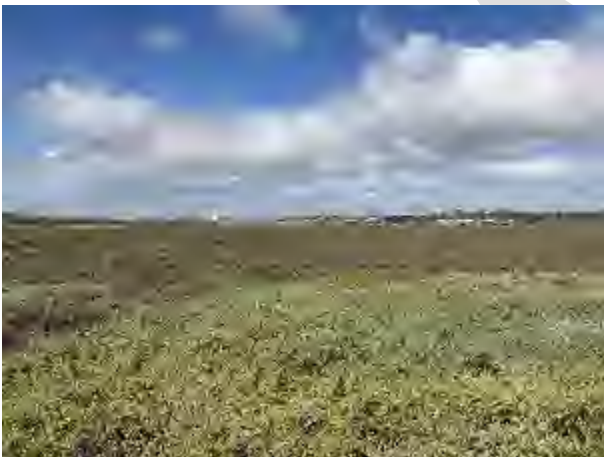
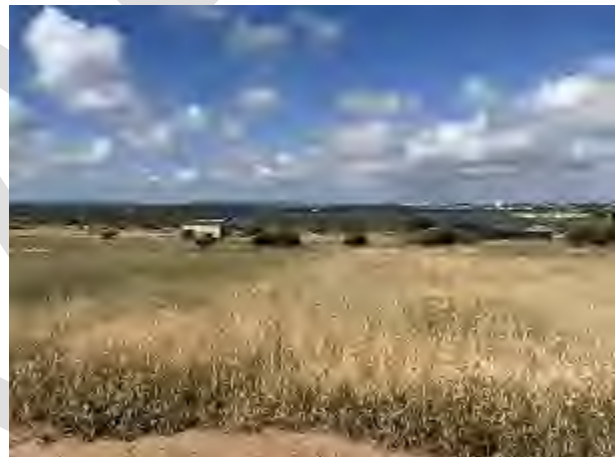
B-2 Samphire Wetland

New developments south of Samphire wetland has very little stormwater infrastructure and not sedimentation collection infrastructure to protect wetland. Erosion occurring at several locations.

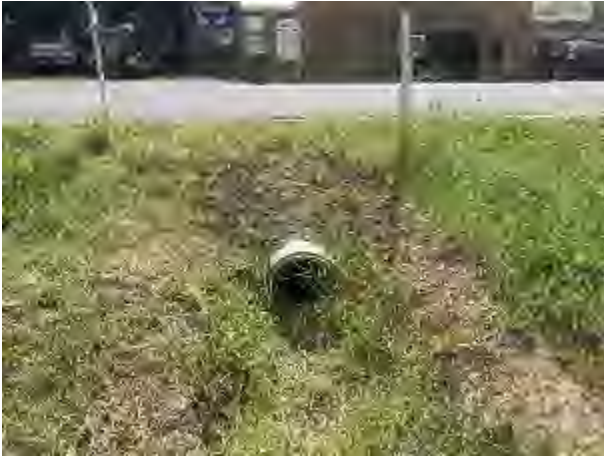
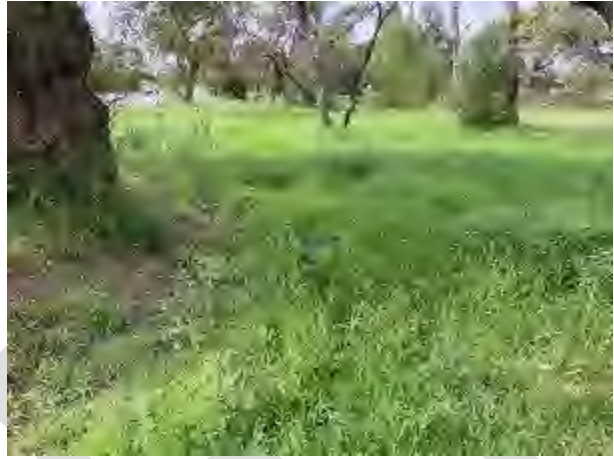
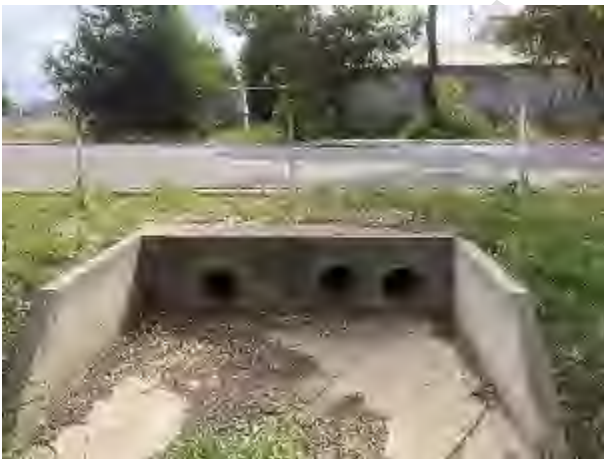
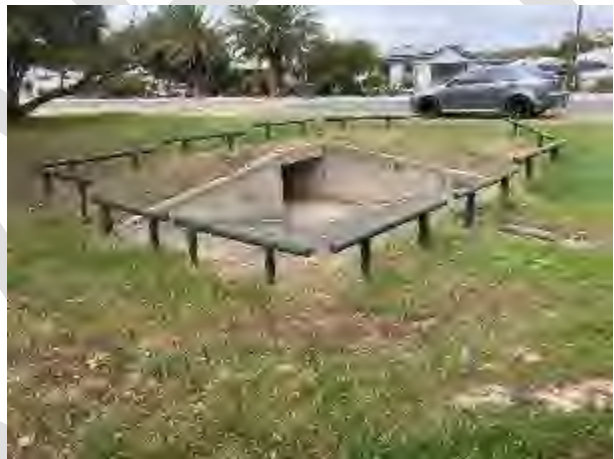
B-3 Bay Road

Crash repairs has experienced flooding in the past but no recent flooding reported.

- **Bay Road** – Crash repairs has experienced flooding in the past but no recent flooding reported. New skate park, stormwater infrastructure possibly insufficient. Possible location for detention basin on golf course at low point on Montgomerie Ter. Currently residents are experiencing flood inundation.

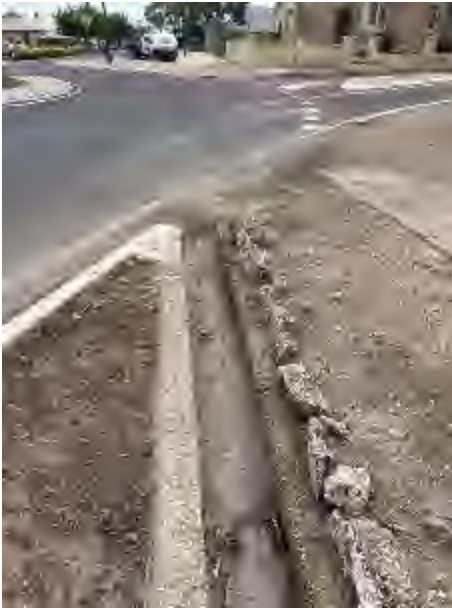
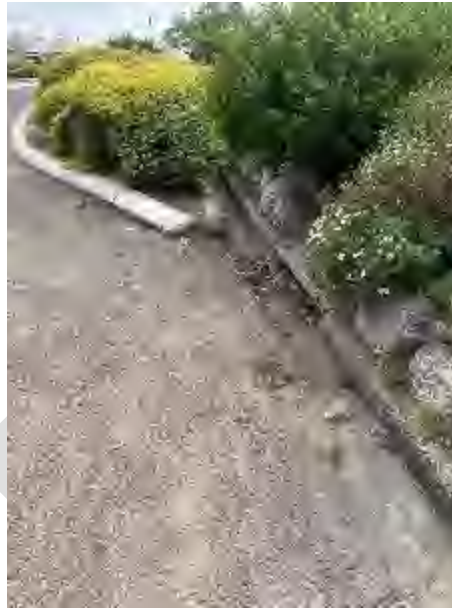
New skate park, stormwater structure possibly insufficient

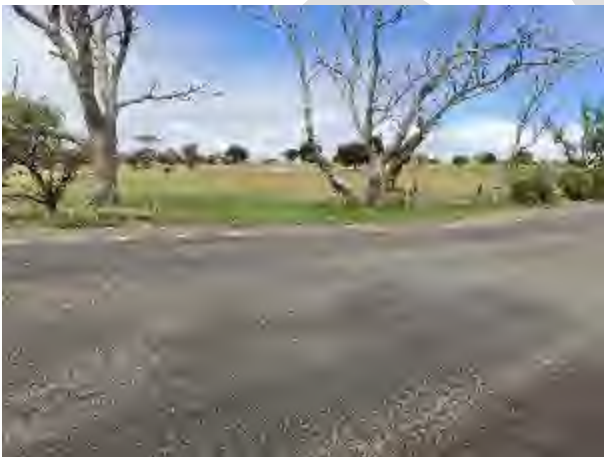
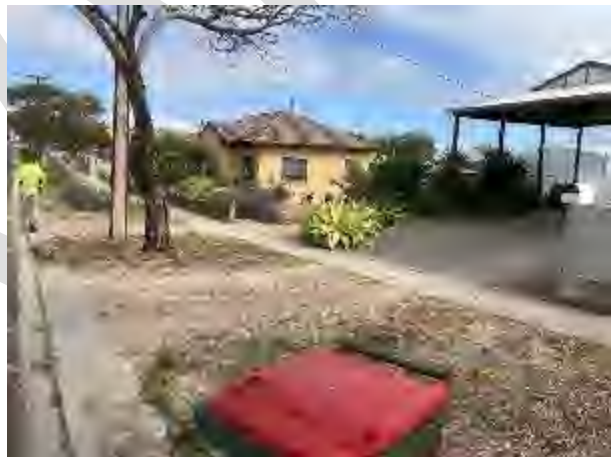
Possible location for detention basin on golf course at low point on Montgomerie Ter. Currently residents are experiencing flood inundation.

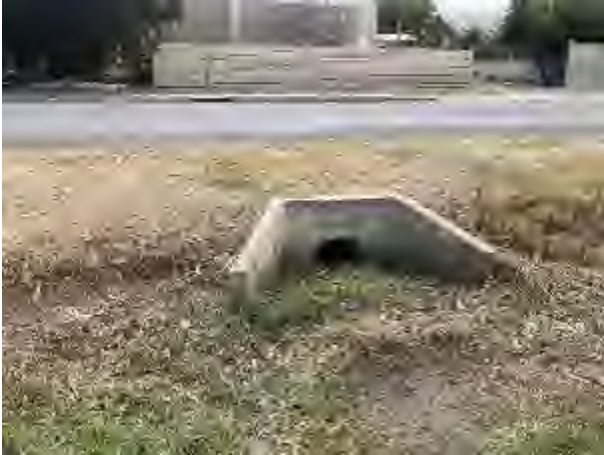
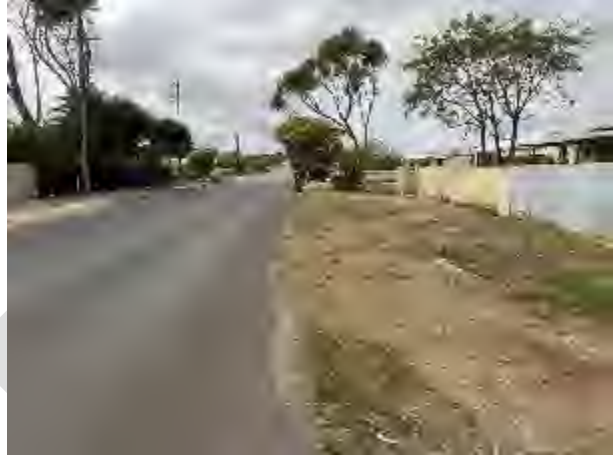
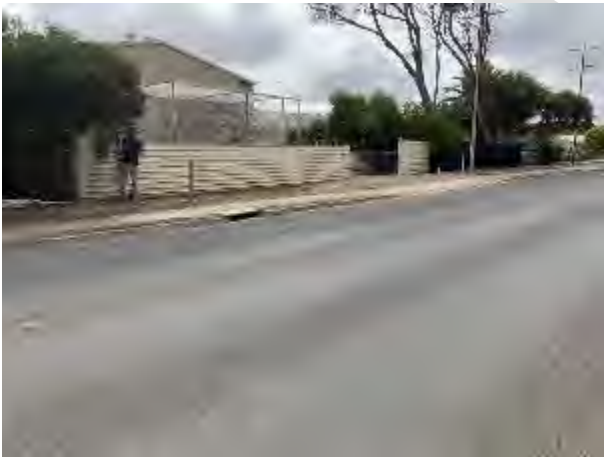
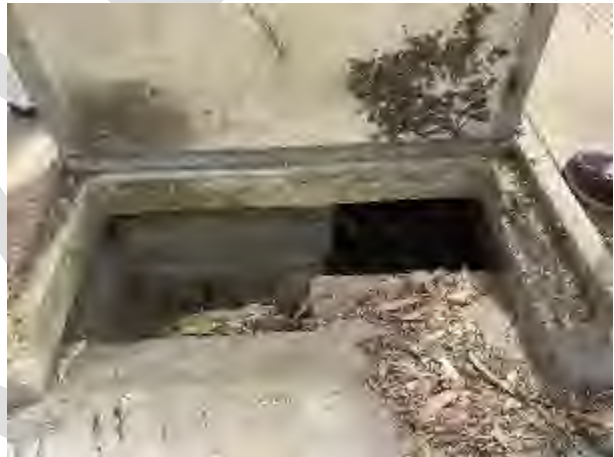
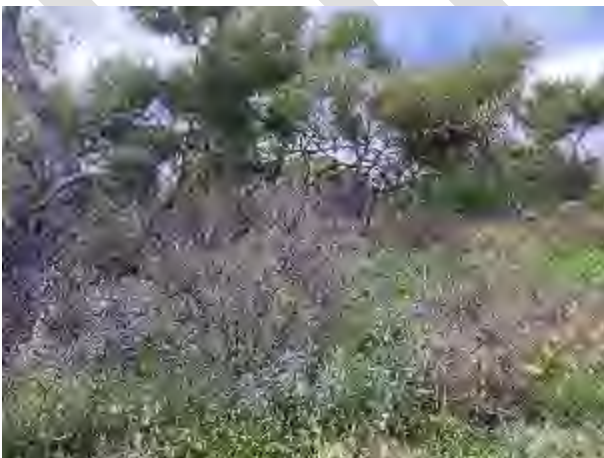
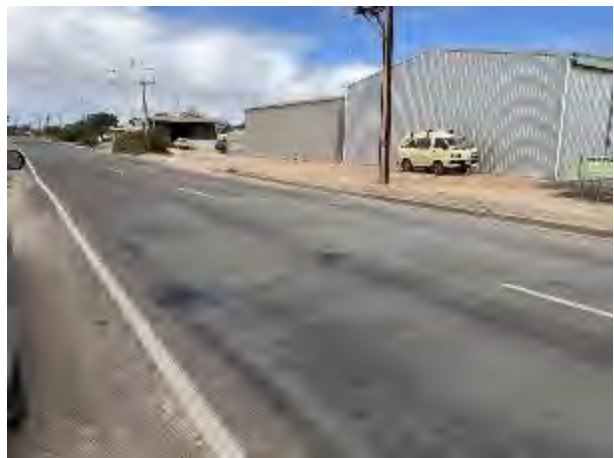
B-4 Mudge Street Terrace

Severe flooding issues. Council could obtain some land for detention basin. Soil in area reported as “always wet”

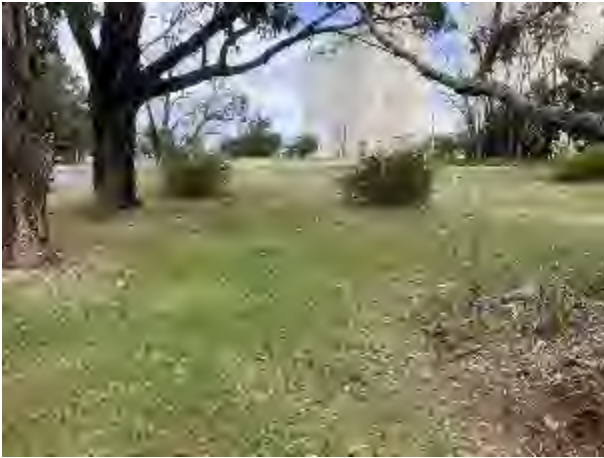
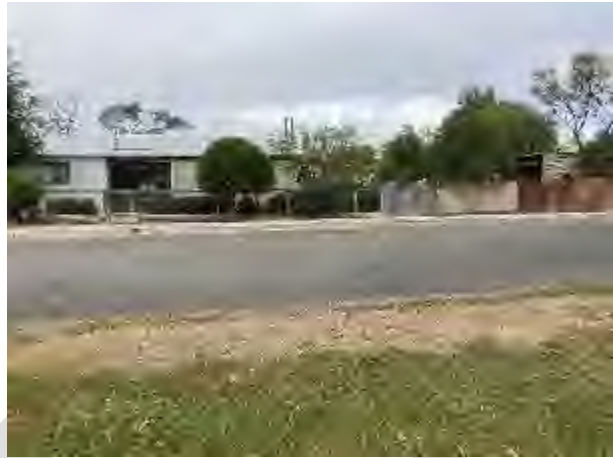
Land use at silos possibly contributing to flooding at Mudge Terrace.

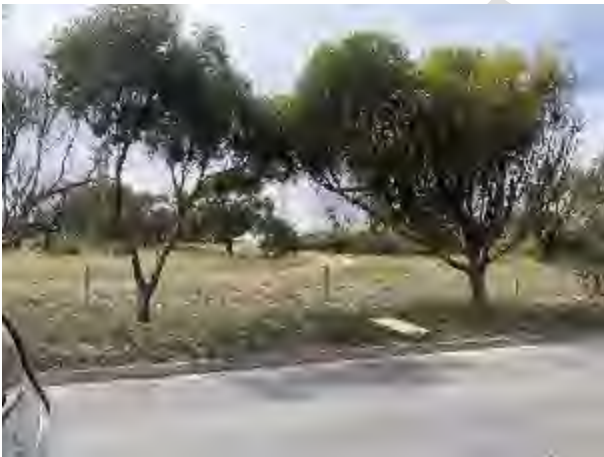
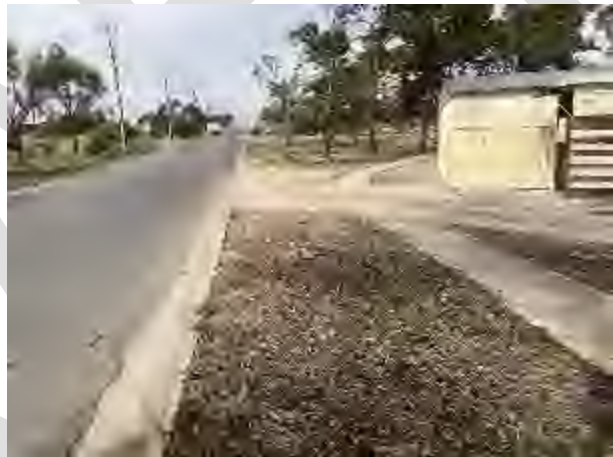
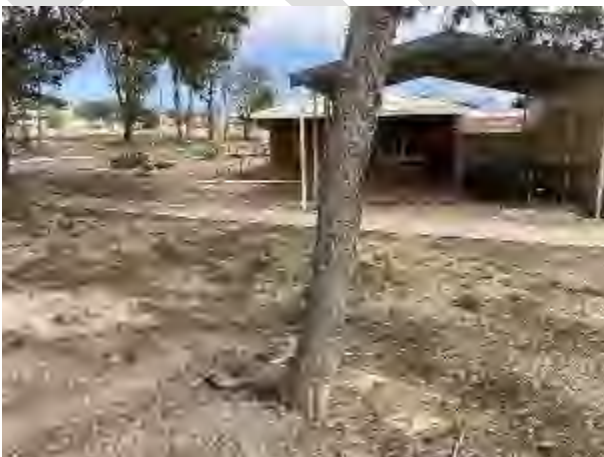
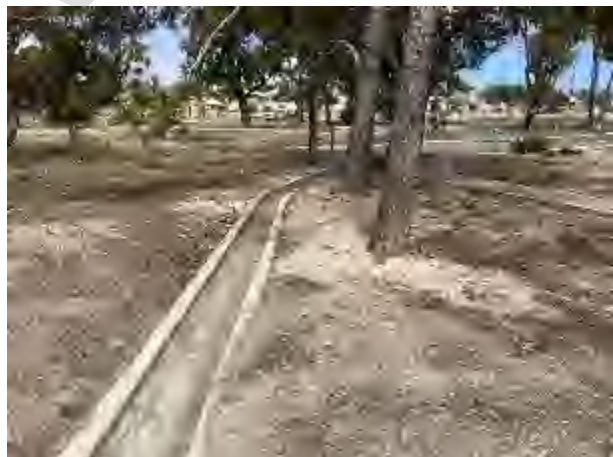
Hospital Drive residence currently experiences flooding and must sandbag during most storm events

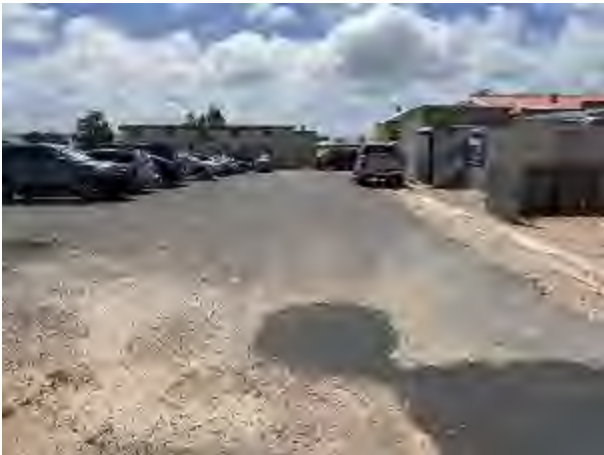
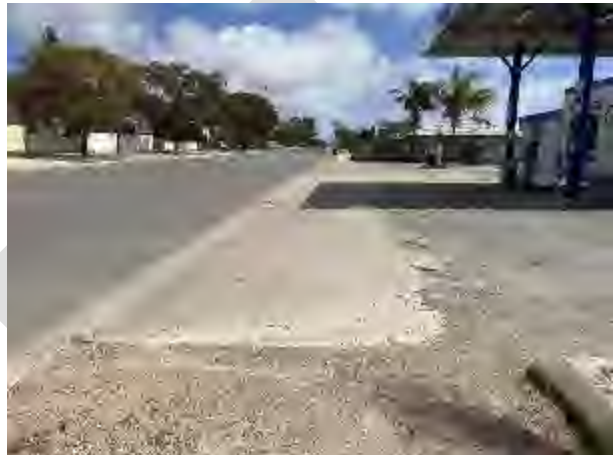
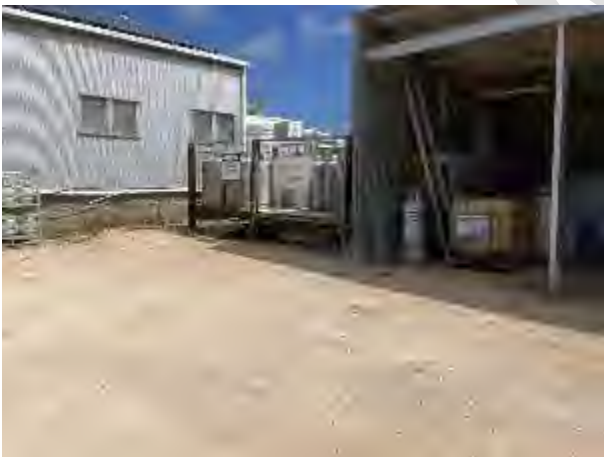
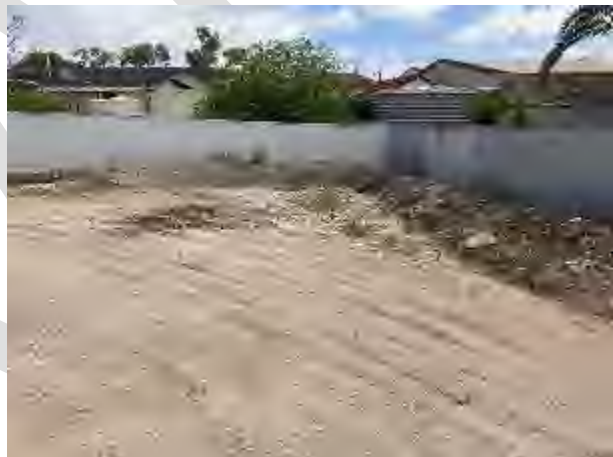
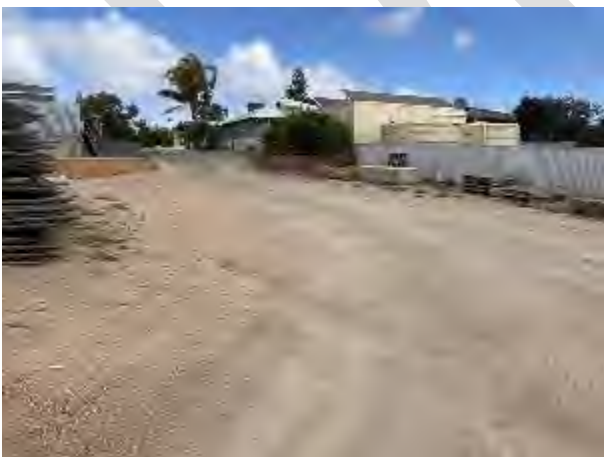
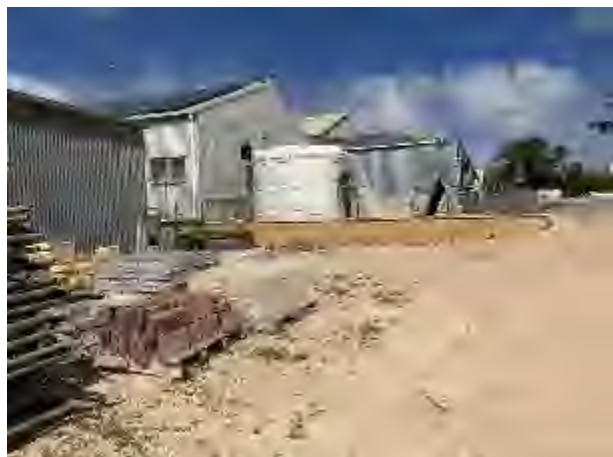
B-5 Main Street Businesses

Kildas business currently flooding downstream neighbours. Owner has tried to resolve issues by building infiltration basin on property. Council stormwater reserve to the east of property to be formalised and utilised by Kildas business. Hotel downstream wants to resurface parking area in near future. Kildas owner reported that all roof water is currently being captured but that stormwater tank overflows and floods downstream.

- **Main Street businesses** – Killa’s business currently flooding downstream neighbours. Owner has tried to resolve issues by building infiltration basin on property. Council stormwater reserve to the east of property to be formalised and utilised by Killa’s business. Hotel downstream wants to resurface parking area in near future. Killa’s owner reported that all roof water is currently being captured but that stormwater tank overflows and floods downstream.
