Stormwater Management Plan

Streaky Bay Stormwater Management Plan Review

District Council of Streaky Bay

19 February 2024

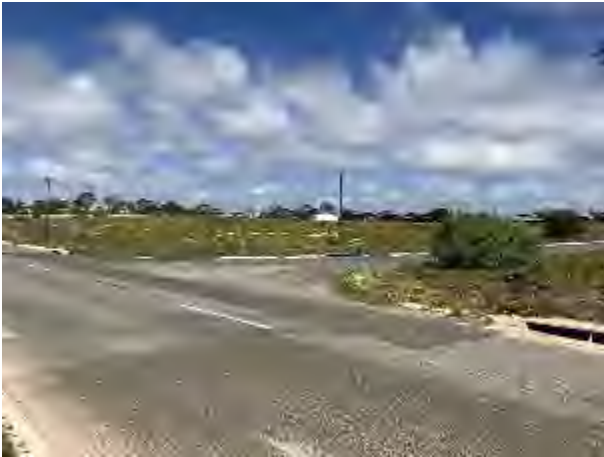
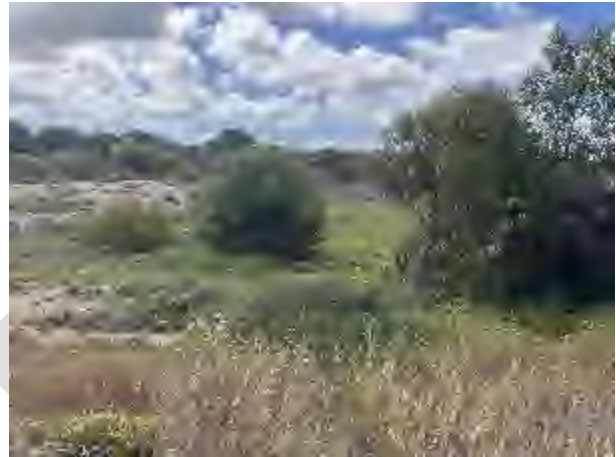
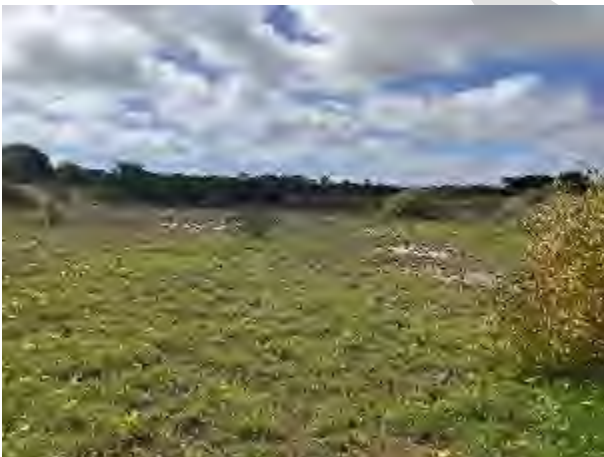
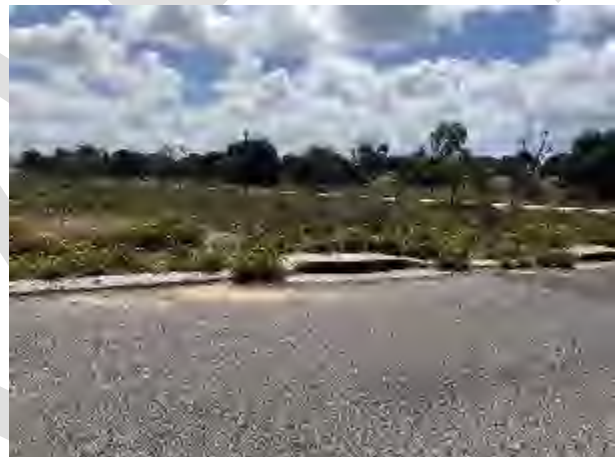
B-6 General Drive Around

Clearwater development east of silos has large retention basin that is not nearly fully utilised. If stormwater from silos can be redirected to this infrastructure it could alleviate flooding at Mudge Terrence
