Tree Assessment & Tree Risk Assessment Report

Wells Street Streaky Bay

The District Council of Streaky Bay

12 April 2023

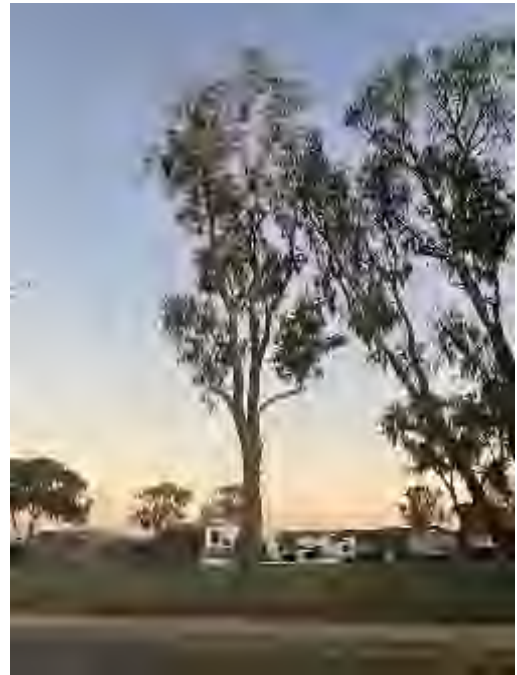
Height (m): 21	Structure: Poor
Width (m): 11	Health: Very poor
DBH (cm): 55 Measured	Maturity: Overmature
Origin: Australian	ULE (years): 1 - 5
Amenity value: Moderate	Form: Poor
Works Required: Irrigate	Dormancy: Evergreen
Priority: High	Recommendation: Retain.

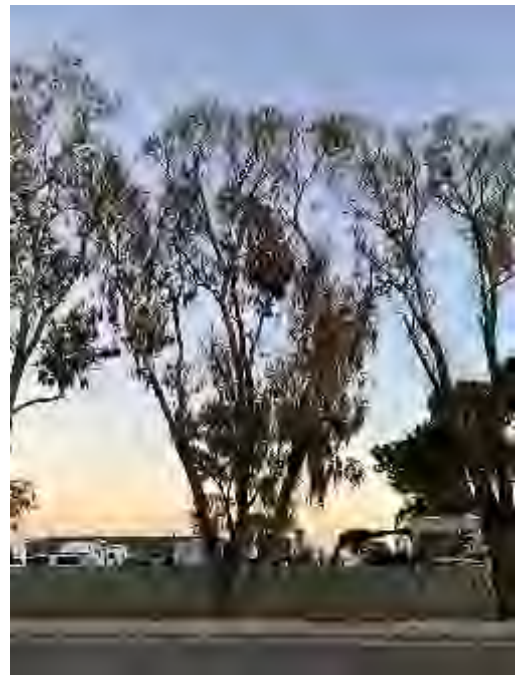
Height (m): 18	Structure: Poor
Width (m): 15	Health: Very poor
DBH (cm): 89 Measured	Maturity: Overmature
Origin: Australian	ULE (years): 1 - 5
Amenity value: Moderate	Form: Poor
Works Required: Irrigate	Dormancy: Evergreen
Priority: High	Recommendation: Retain.

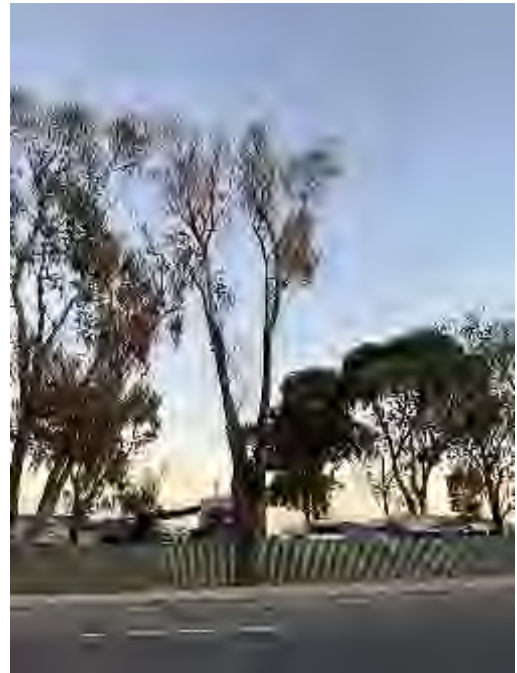
Height (m): 18	Structure: Poor
Width (m): 9	Health: Very poor
DBH (cm): 61 Measured	Maturity: Overmature
Origin: Australian	ULE (years): 1 - 5
Amenity value: Moderate	Form: Poor
Works Required: Irrigate	Dormancy: Evergreen
Priority: High	Recommendation: Retain.

Risk Score Values: Risk Score: 1: 172000

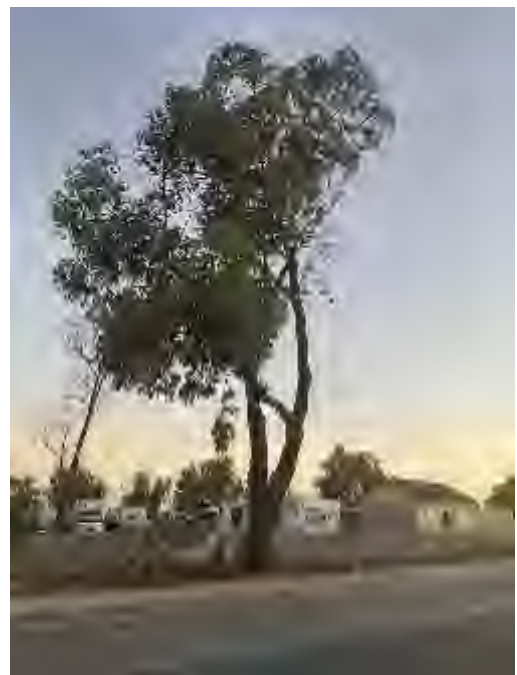
Height (m): 17	Structure: Poor
Width (m): 15	Health: Poor
DBH (cm): 82 Measured	Maturity: Overmature
Origin: Australian	ULE (years): 15 - 25
Amenity value: Moderate	Form: Fair
Works Required:	Dormancy: Evergreen
Structural prune	Recommendation: Retain.
Priority: Very High

Risk Score Values: Risk Score: 1: 40

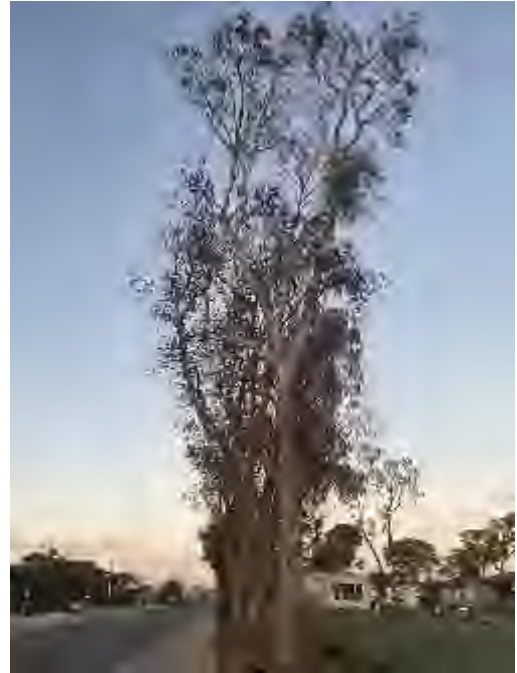
Risk Score Values: Risk Score: 1: 172000

Occupancy = Property-\$22,000 - \$80,000. Pedestrians->10 per hour - 36 per hour. Road-1,305 vehicles @ 110kph; 1,617 vehicles @ 80kph; 2,335 vehicles @ 50kph: 1/20 (20). Failure Size = 10cm - 25cm 1/8.6 (8.6). Failure potential = 0.01% - 0.1% 1/1,000 (1000).

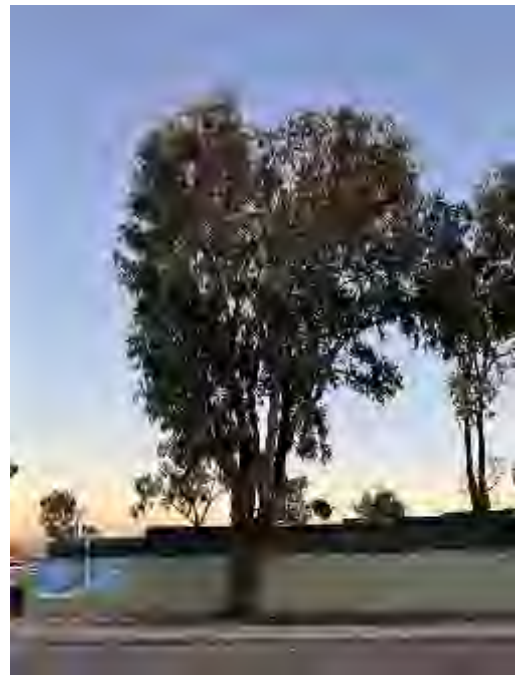
Risk Score Values: Risk Score: 1: 1720000

Occupancy = Property-\$22,000 - \$80,000. Pedestrians->10 per hour - 36 per hour. Road-1,305 vehicles @ 110kph; 1,617 vehicles @ 80kph; 2,335 vehicles @ 50kph: 1/20 (20). Failure Size = 10cm - 25cm 1/8.6 (8.6). Failure potential = 0.001% - 0.01% 1/10,000 (10000).

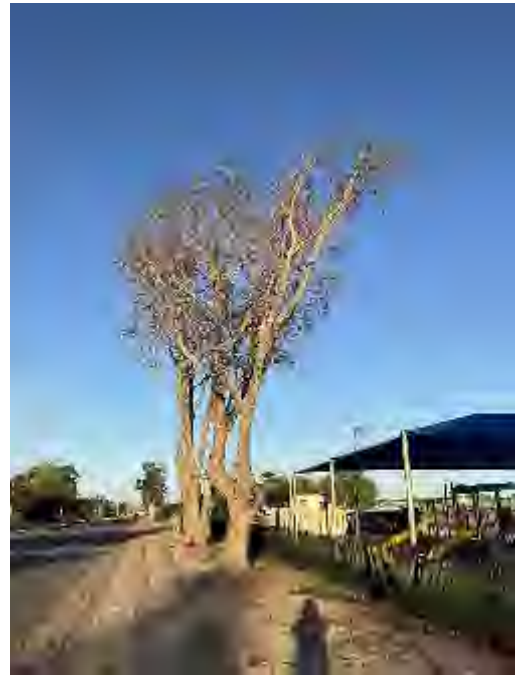
Risk Score Values: Risk Score: 1: 164000

Occupancy = Property-\$22,000 - \$80,000. Pedestrians->10 per hour - 36 per hour. Road-1,305 vehicles @ 110kph; 1,617 vehicles @ 80kph; 2,335 vehicles @ 50kph: 1/20 (20). Failure Size = 2.5cm - 10cm 1/82 (82). Failure potential = 0.1% - 1% 1/100 (100).

Remove

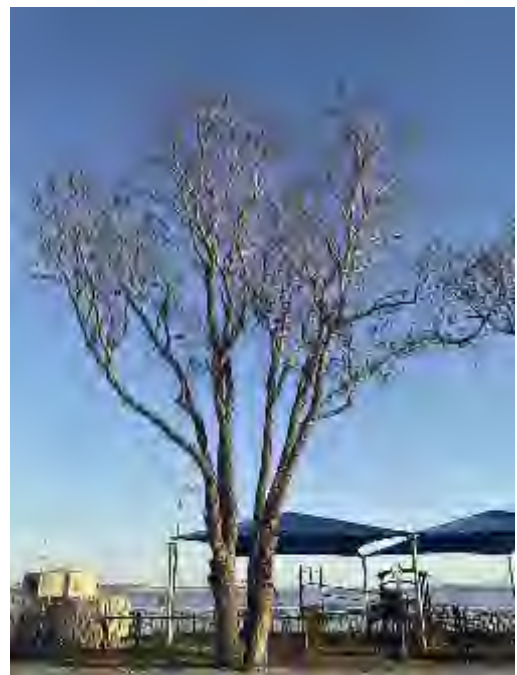
Risk Score Values: Risk Score: 1: 40000

Occupancy = Property-\$22,000 - \$80,000. Pedestrians->10 per hour - 36 per hour. Road-1,305 vehicles @ 110kph; 1,617 vehicles @ 80kph; 2,335 vehicles @ 50kph: 1/20 (20). Failure Size = 25cm - 45cm 1/2 (2). Failure potential = 0.01% - 0.1% 1/1,000 (1000).

Remove

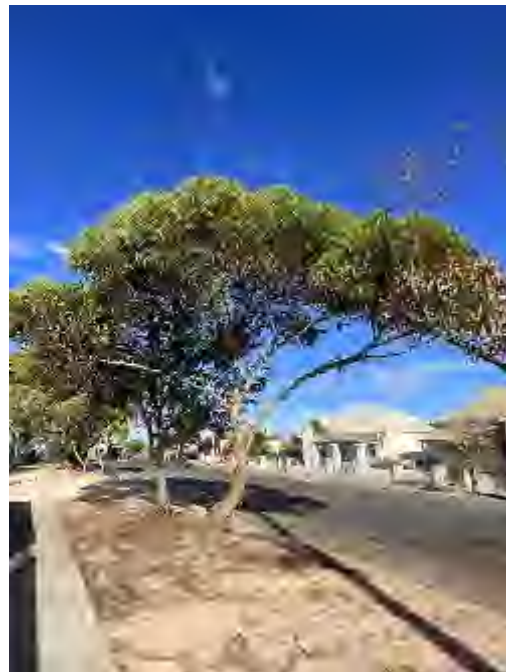
Tree ID: 182

Dormancy: Evergreen
Recommendation: Remove.

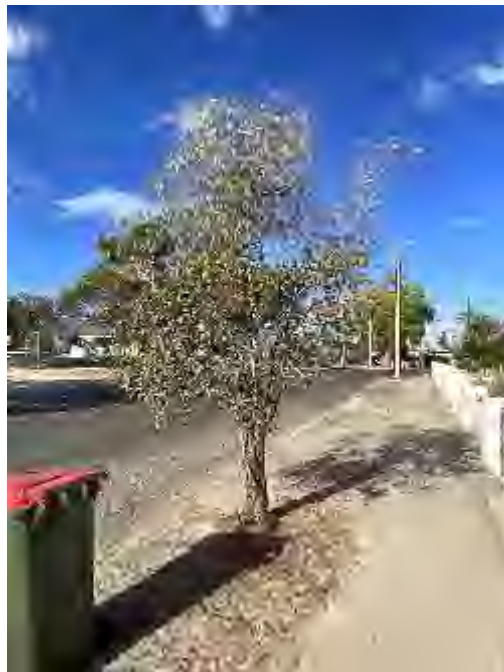
Tree ID: 184

Height (m): 5	Structure: Fair
Width (m): 3	Health: Poor
DBH (cm): 13 Measured	Maturity: Semi Mature
Origin: Australian	ULE (years): 15 - 25
Amenity value: Low	Form: Fair
	Dormancy: Evergreen
Works Required:	Recommendation: Retain.
Deadwood > 25mm

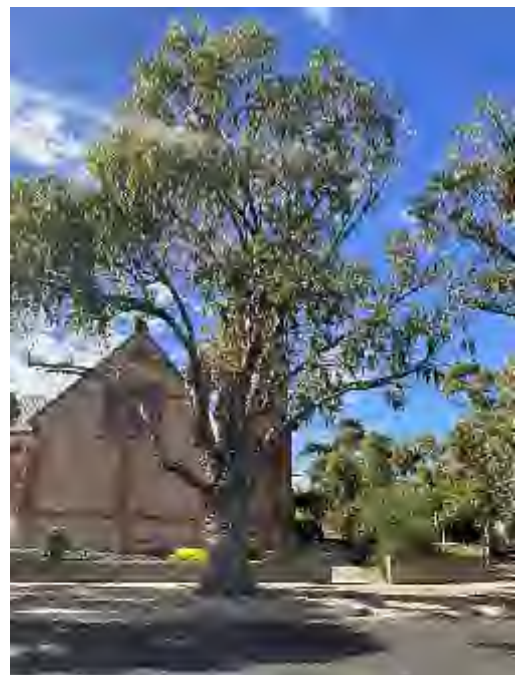
Tree ID: 197

Height (m): 6	Structure: Poor
Width (m): 7	Health: Dead
DBH (cm): 15 Measured	Maturity: Semi Mature
Origin: Australian	ULE (years): 0
Amenity value: Low	Form: Fair
	Dormancy: Evergreen
Works Required:	Recommendation:
Remove tree	Remove

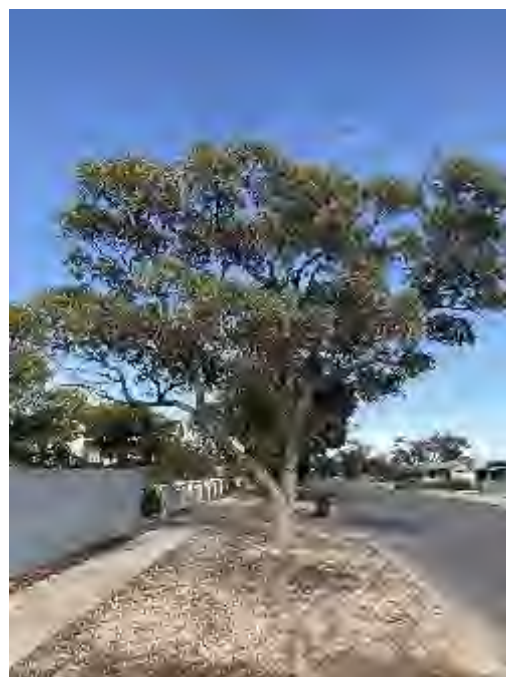
Tree ID: 201

Height (m): 5	Structure: Poor
Width (m): 3	Health: Dead
DBH (cm): 12 Measured	Maturity: Overmature
Origin: Australian	ULE (years): 0
Amenity value: Low	Form: Poor
	Dormancy: Evergreen
Works Required:	Recommendation:
Remove tree	Remove

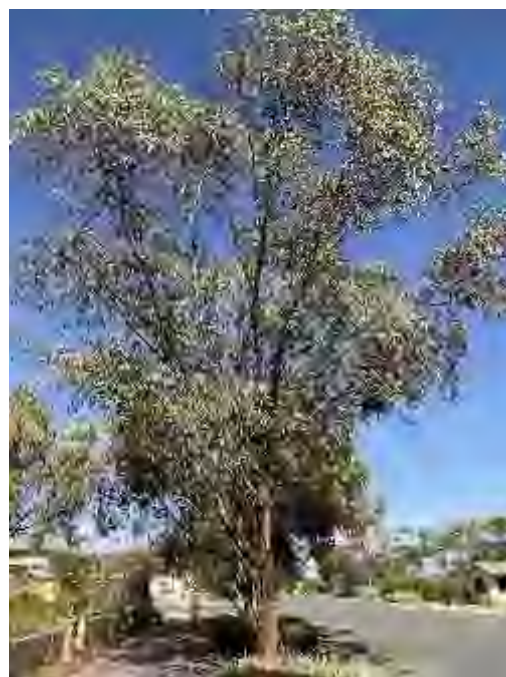
Tree ID: 213

Works Required:	Dormancy: Evergreen
Deadwood > 25mm	Recommendation: Retain.

Priority: Moderate

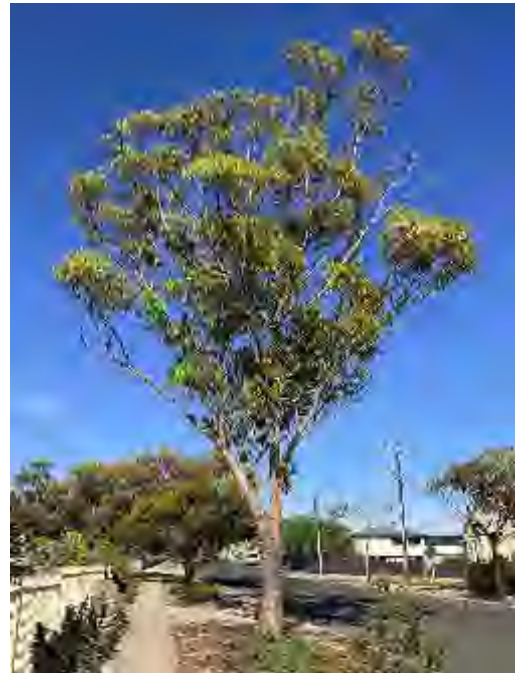
Tree ID: 214

Works Required:	Dormancy: Evergreen
Deadwood > 25mm	Recommendation: Retain.

Priority: Moderate

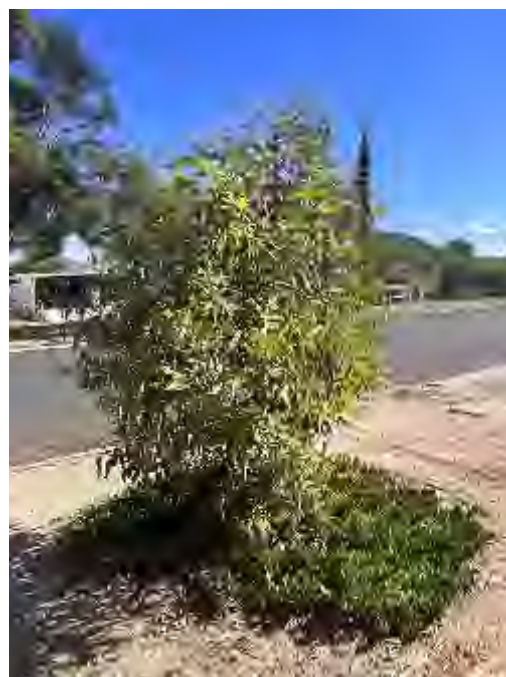
Tree ID: **227**

Height (m): 4	Structure: Poor
Width (m): 2	Health: Dead
DBH (cm): 5 Measured	Maturity: Overmature
Origin: Australian	ULE (years): 0
Amenity value: Very low	Form: Good
	Dormancy: Evergreen
Works Required:	Recommendation:
Remove tree	Remove

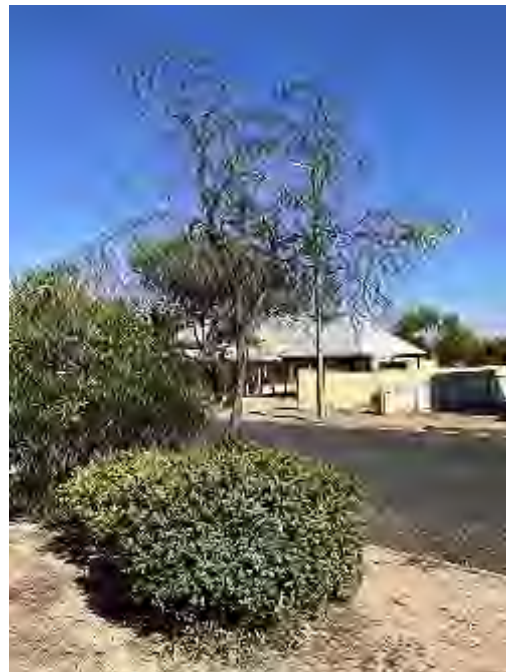
Tree ID: **228**

Height (m): 7	Structure: Fair
Width (m): 7	Health: Fair
DBH (cm): 22 Measured	Maturity: Mature
Origin: Melbourne	ULE (years): 5 - 15
Amenity value: Low	Form: Good
	Dormancy: Evergreen
Works Required:	Recommendation: Retain.

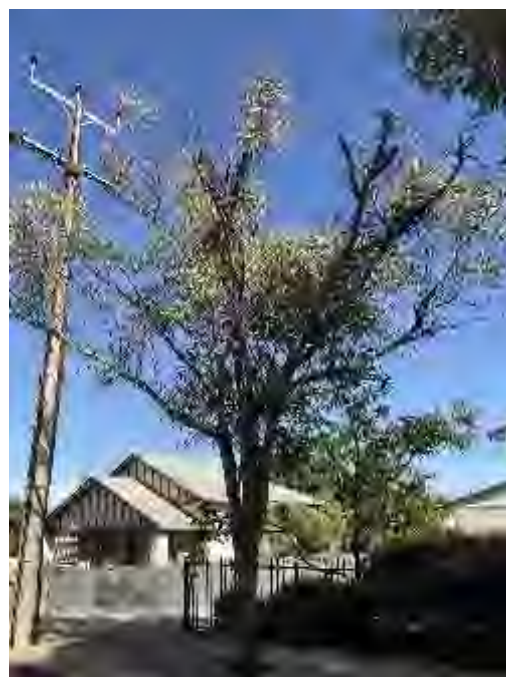
Tree ID: 229

Height (m): 4	Structure: Poor
Width (m): 2	Health: Dead
DBH (cm): 15 Measured	Maturity: Overmature
Origin: Australian	ULE (years): 0
Amenity value: Very low	Form: Very Poor
	Dormancy: Evergreen
Works Required:	Recommendation:
Remove tree	Remove.

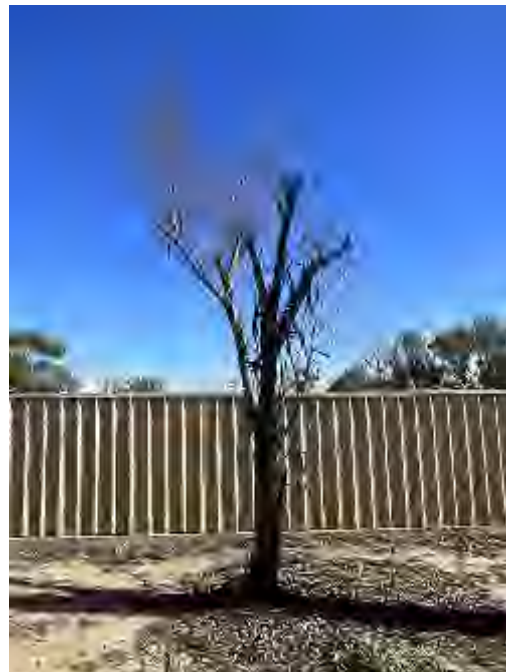
Tree ID: 230

Height (m): 8	Structure: Good
Width (m): 9	Health: Fair
DBH (cm): 27 Measured	Maturity: Mature
Origin: Australian	ULE (years): > 50
Amenity value: Moderate	Form: Good
	Dormancy: Evergreen
Works Required: Mulch	Recommendation: Retain.

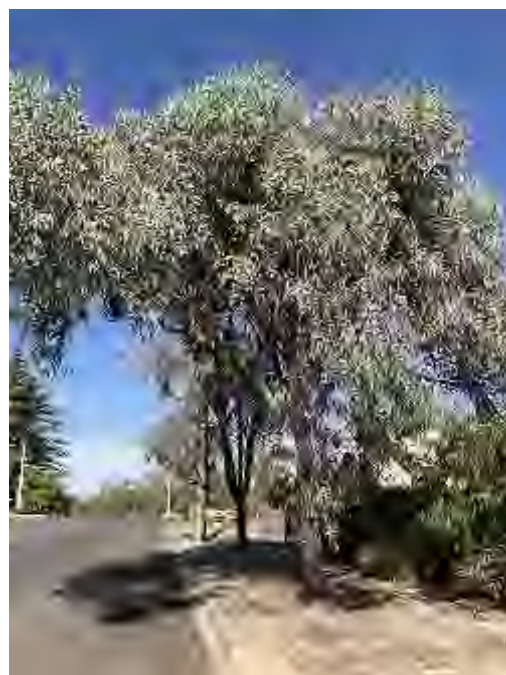
Tree ID: 231

Height (m): 6	Structure: Poor
Width (m): 3	Health: Dead
DBH (cm): 11 Measured	Maturity: Semi Mature
Origin: Melbourne	ULE (years): 0
Amenity value: Low	Form: Good
	Dormancy: Evergreen
Works Required:	Recommendation:
Remove tree	Remove

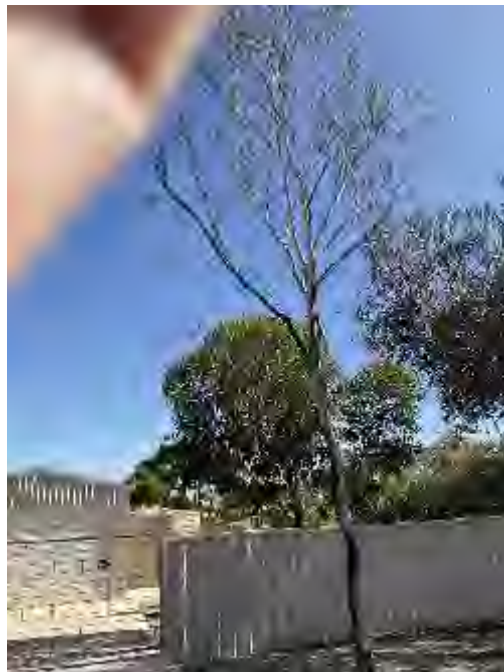
Tree ID: 232

Height (m): 6	Structure: Fair
Width (m): 5	Health: Fair
DBH (cm): 23 Measured	Maturity: Mature
Origin: Australian	ULE (years): 5 - 15
Amenity value: Moderate	Form: Fair
	Dormancy: Evergreen
Works Required:	Recommendation: Retain.
Powerline clearance

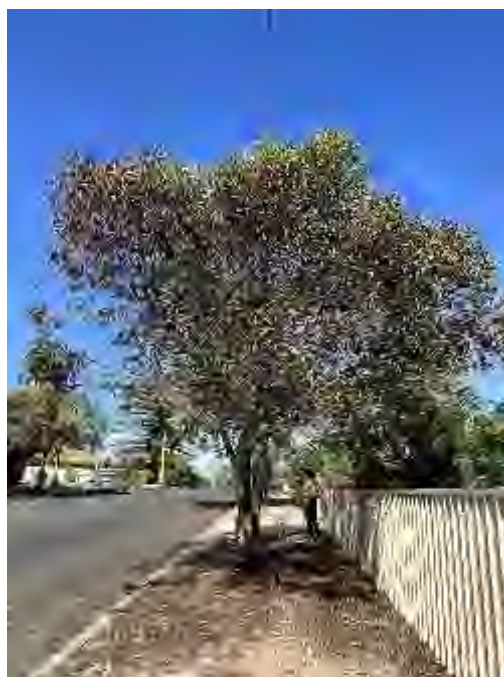
Tree ID: 233

Height (m): 6	Structure: Fair
Width (m): 4	Health: Very poor
DBH (cm): 18 Measured	Maturity: Semi Mature
Origin: Australian	ULE (years): 0
Amenity value: Low	Form: Good
Works Required:	Dormancy: Evergreen
No action required	Recommendation: Retain.
